EAST BAY DISCHARGERS AUTHORITY
2651 Grant Avenue
San Lorenzo, CA 94580-1841
(510) 278-5910
FAX (510) 278-6547

OPERATIONS & MAINTENANCE COMMITTEE AGENDA

ITEM NO. OM6 NPDES INSPECTION OF MARINA DECHLORINATION FACILITY

NPDES Compliance Evaluation Inspection (CEI) Report

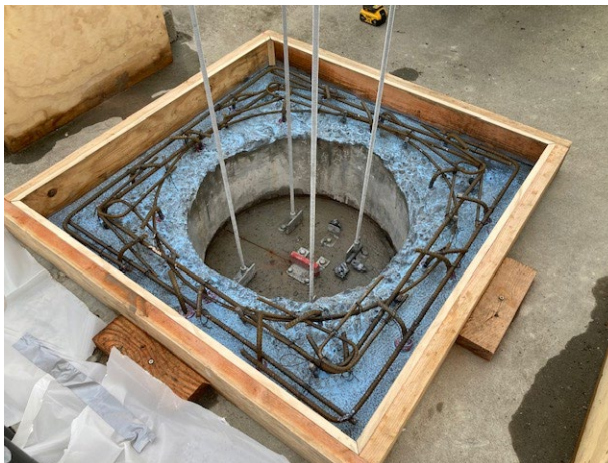
New Pump Base Rebar

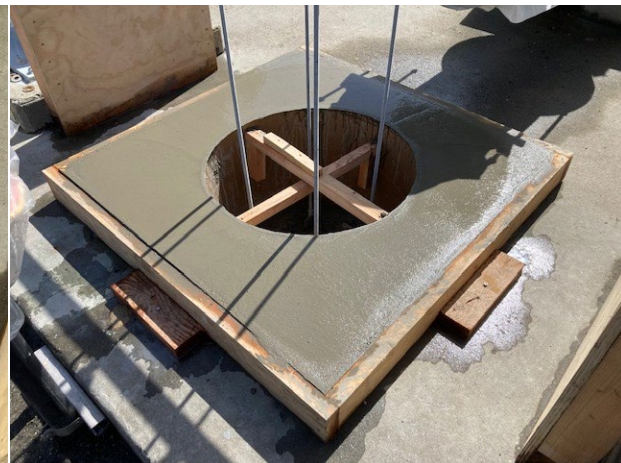
New Concrete Pump Base

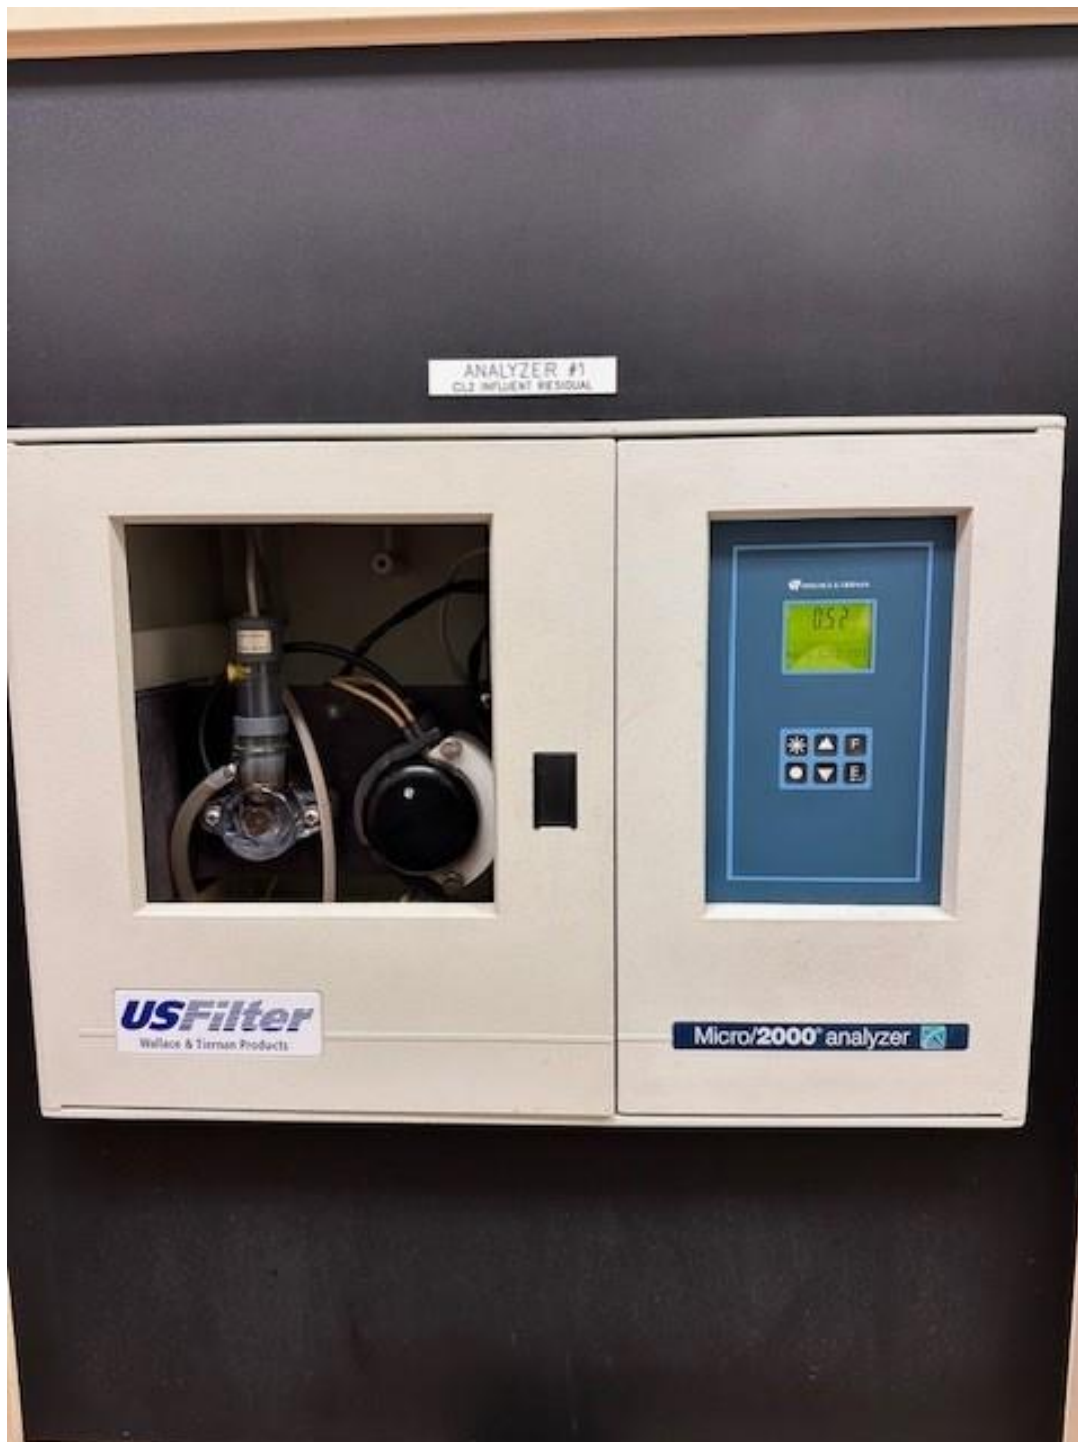
Figure 3. The influent chlorine analyzer read 0.52 mg/L at the time of the inspection.

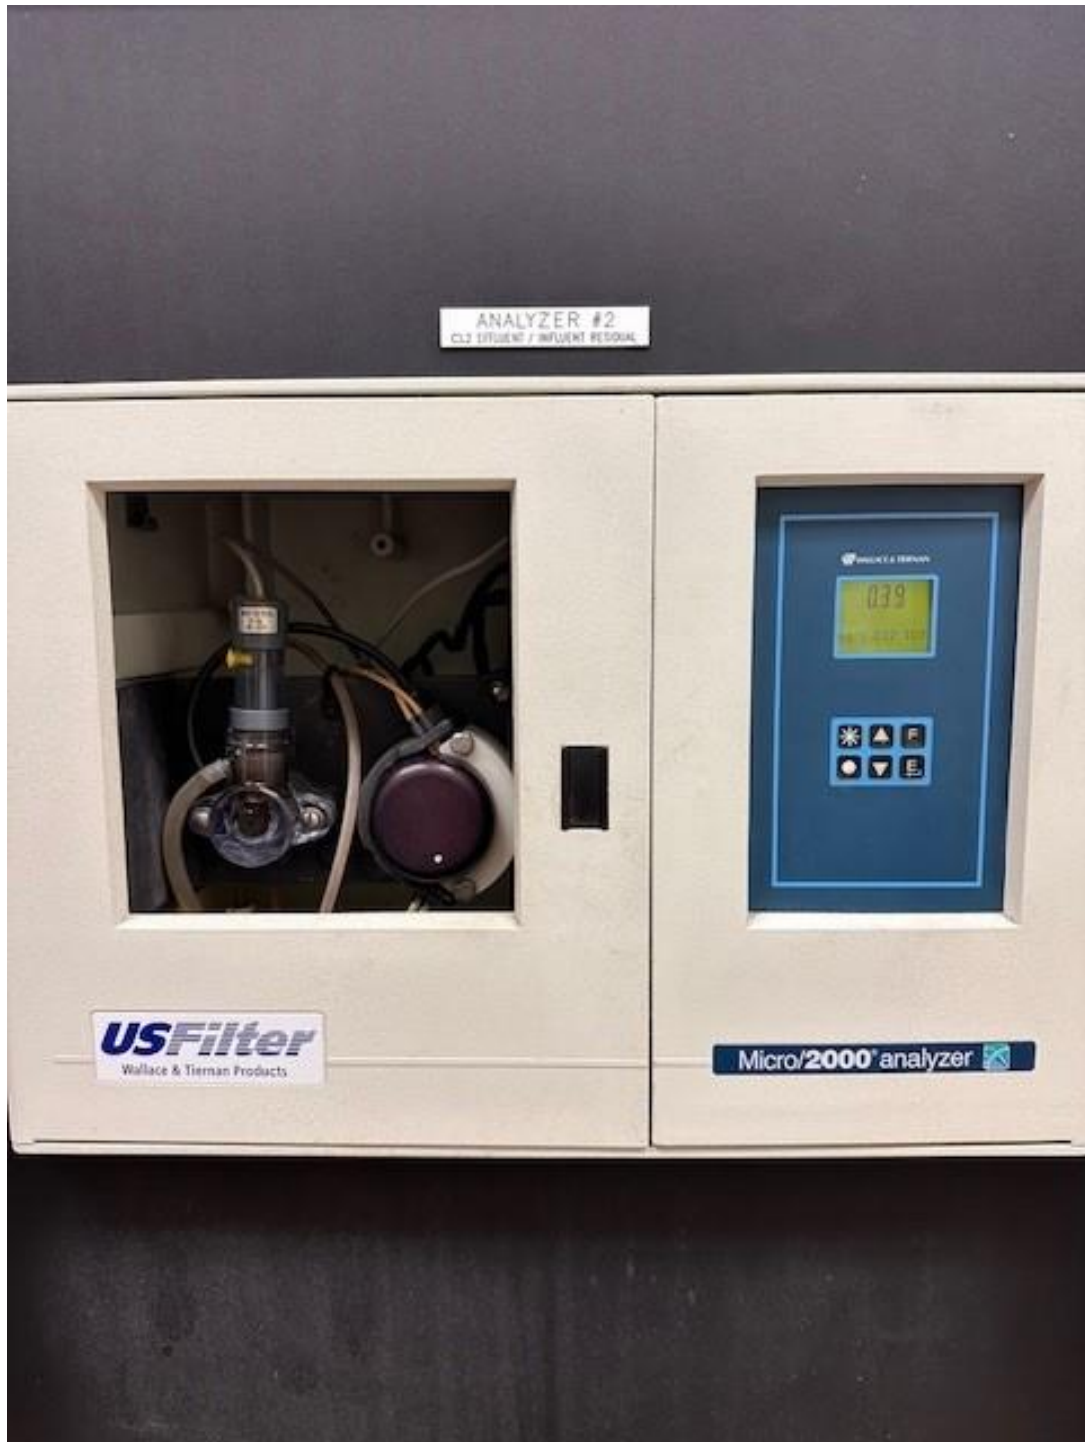
Figure 4. The effluent chlorine analyzer read 0.39 mg/L at the time of the inspection.

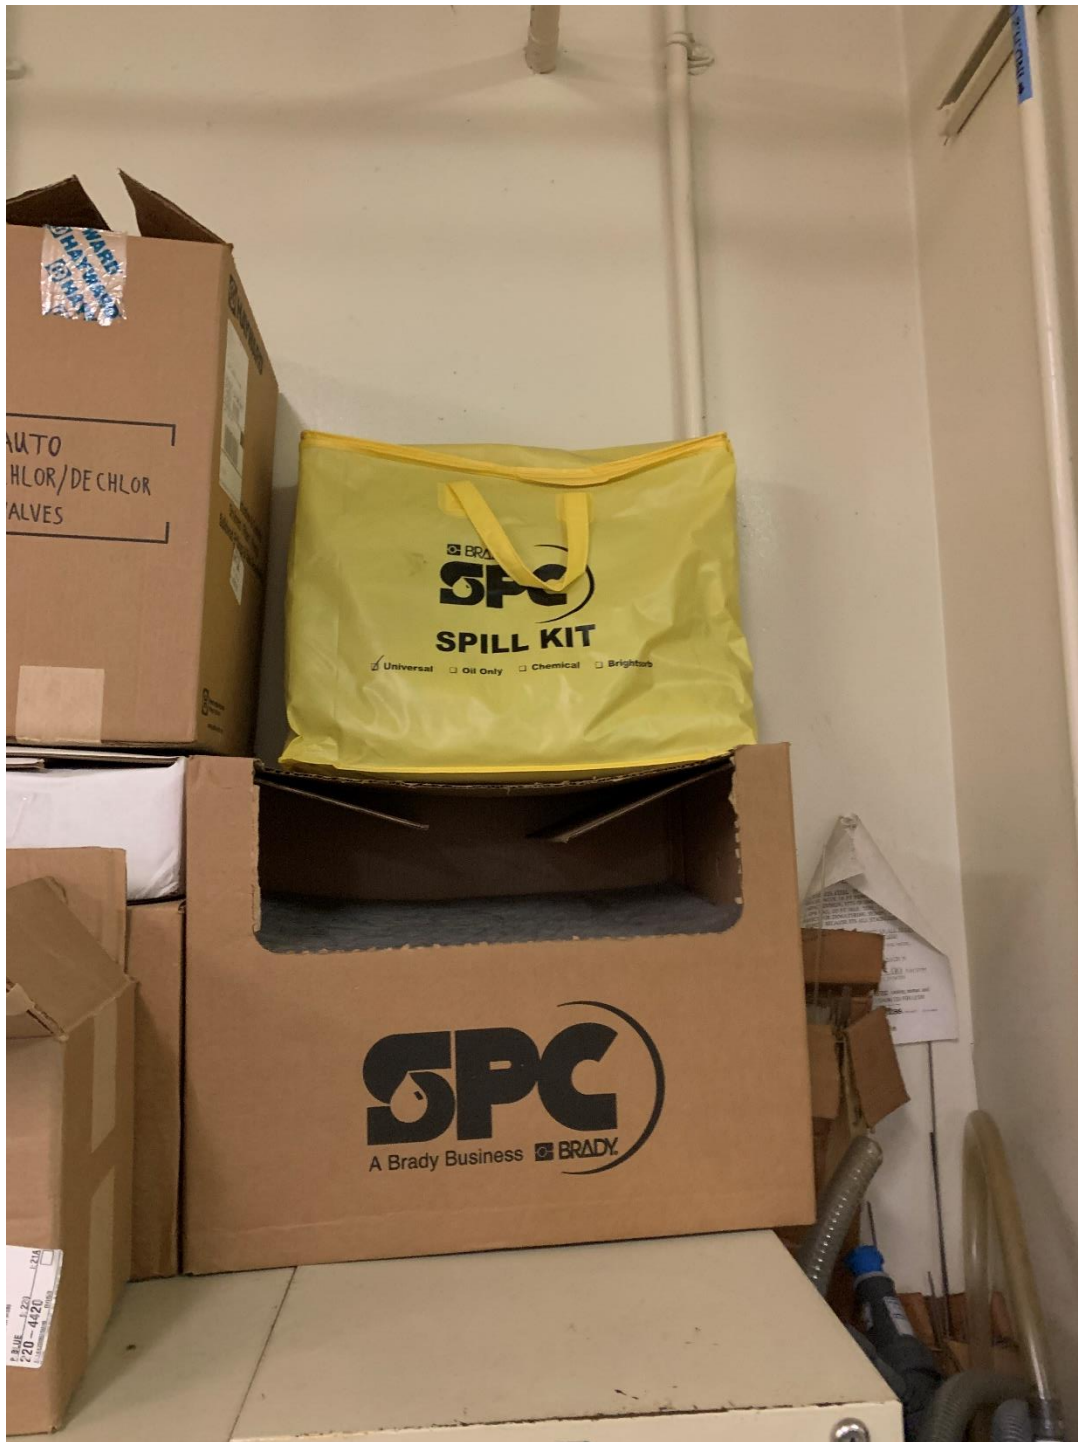
Figure 5. The Facility's storage room contained a spill kit (yellow bag) in the event of a chemical spill.

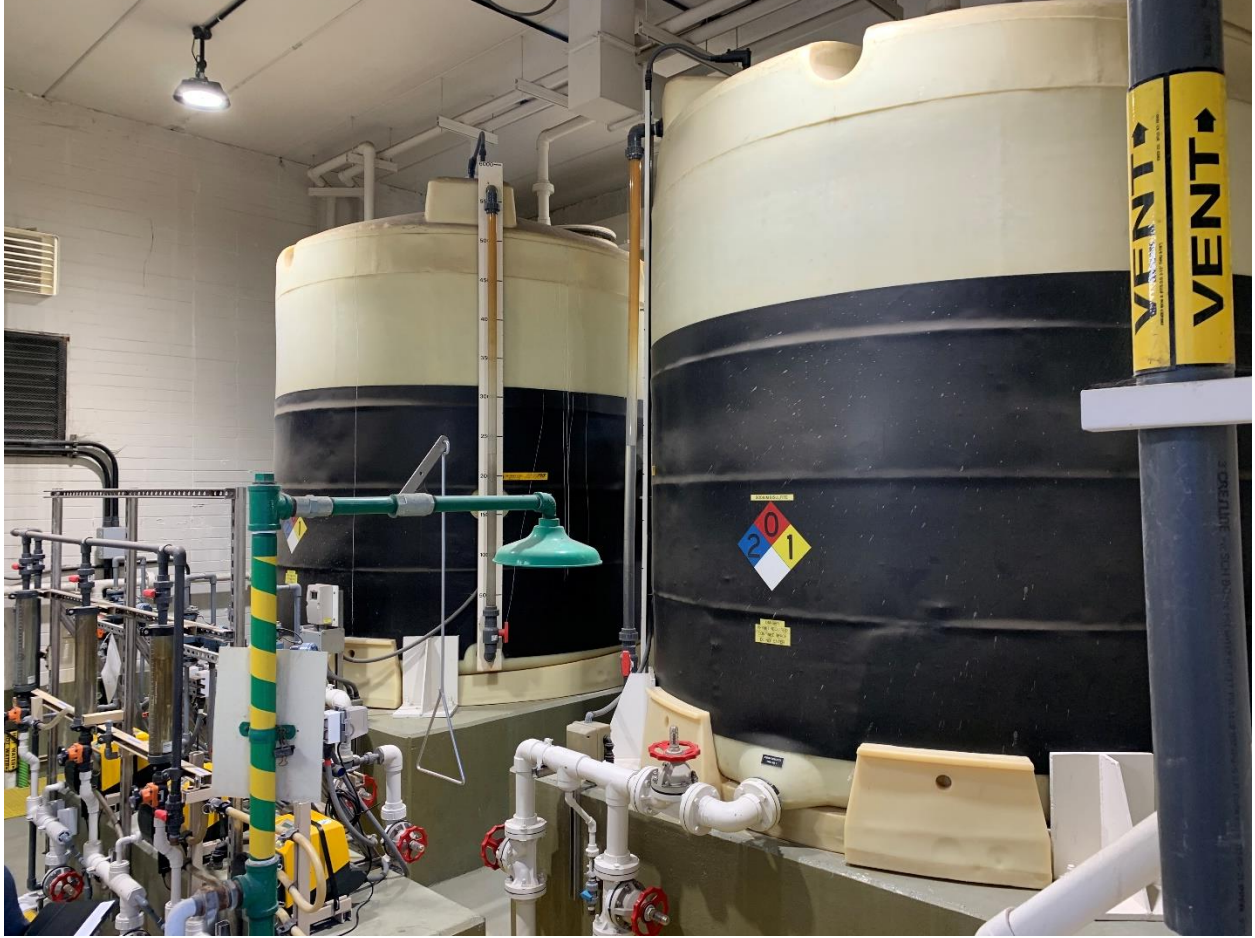
Figure 6. The Facility's sodium bisulfite storage building contained two 6,000-gallon tanks of sodium bisulfite.

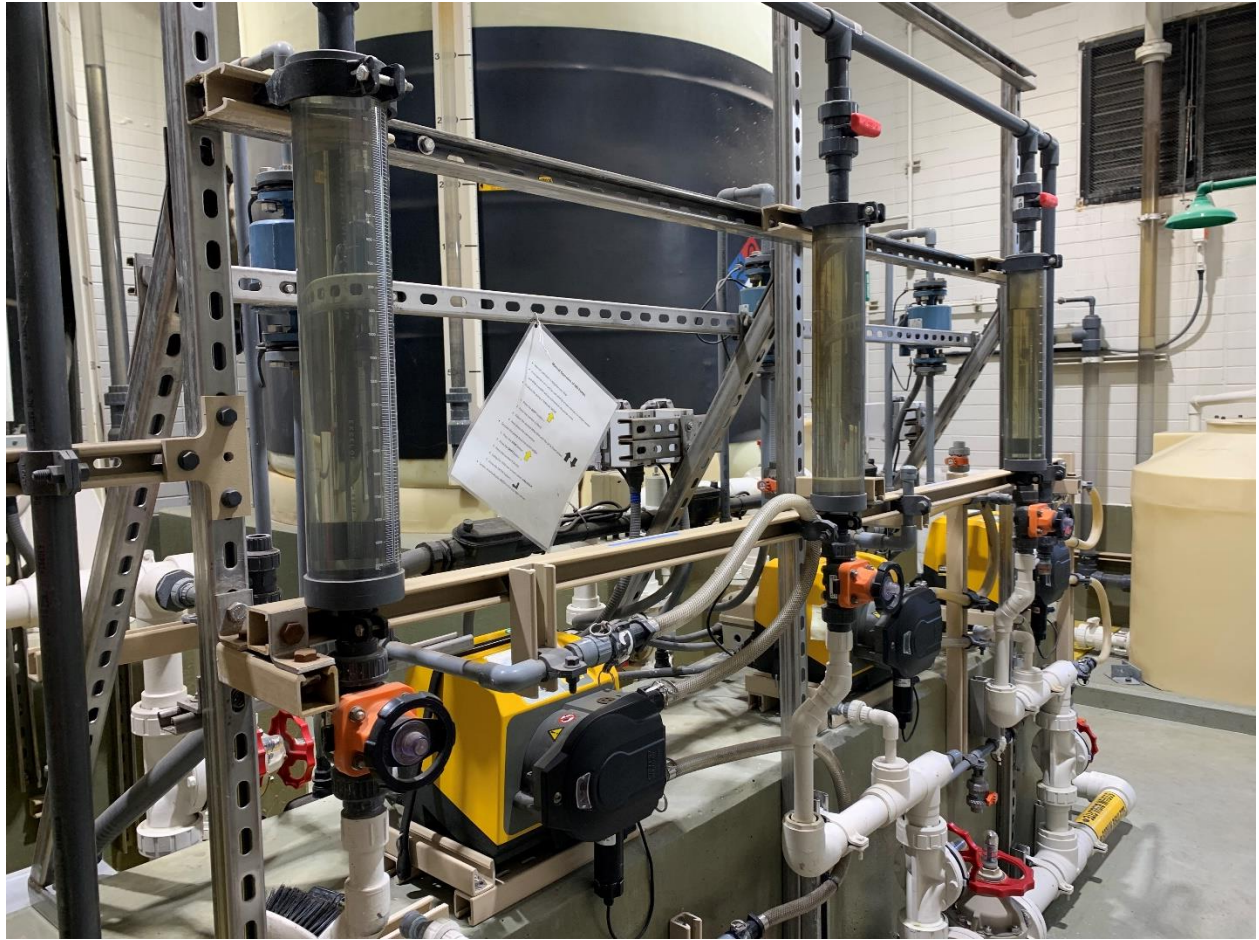
Figure 7. Three sodium bisulfite pumps.

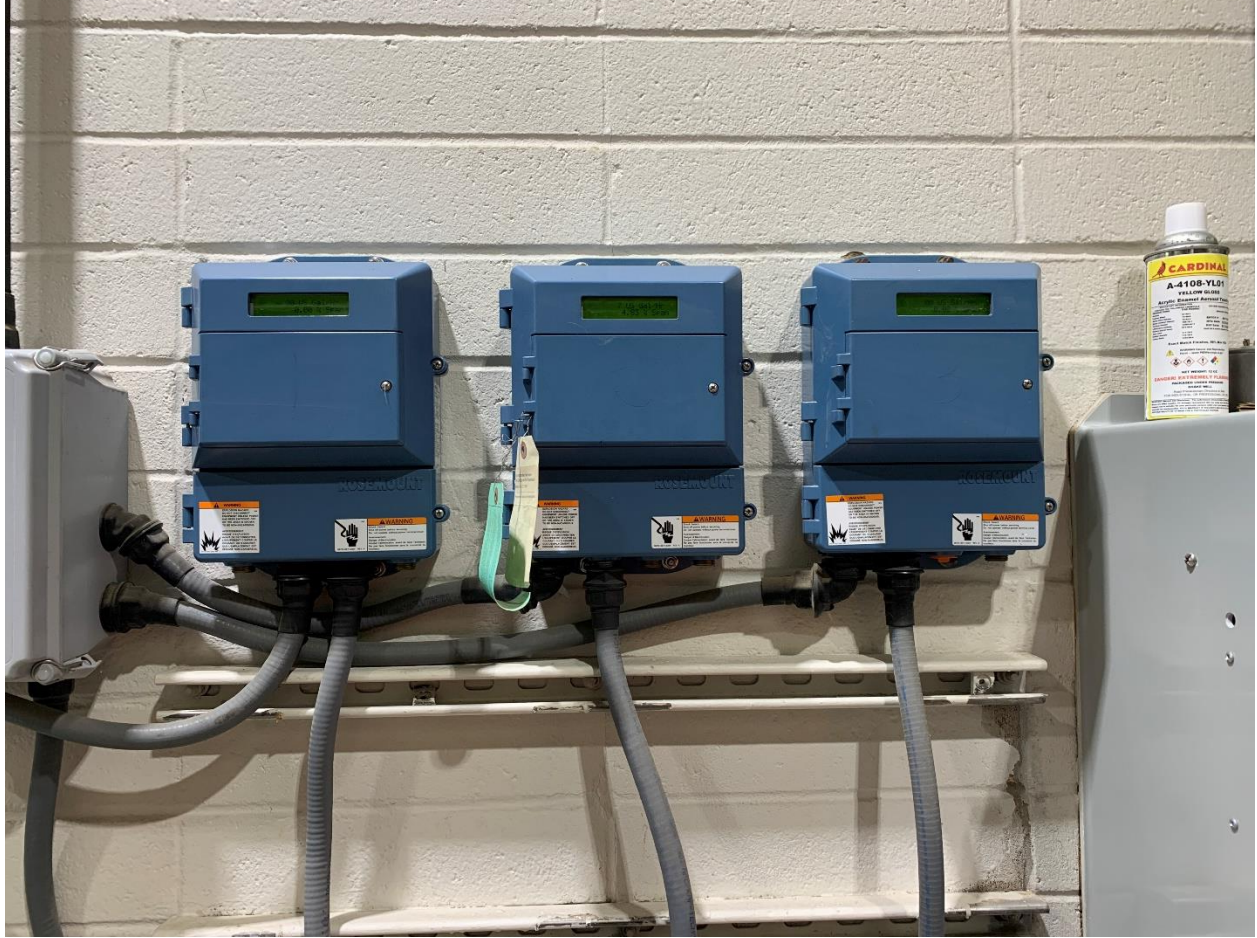
Figure 8. The three sodium bisulfite flow meters.

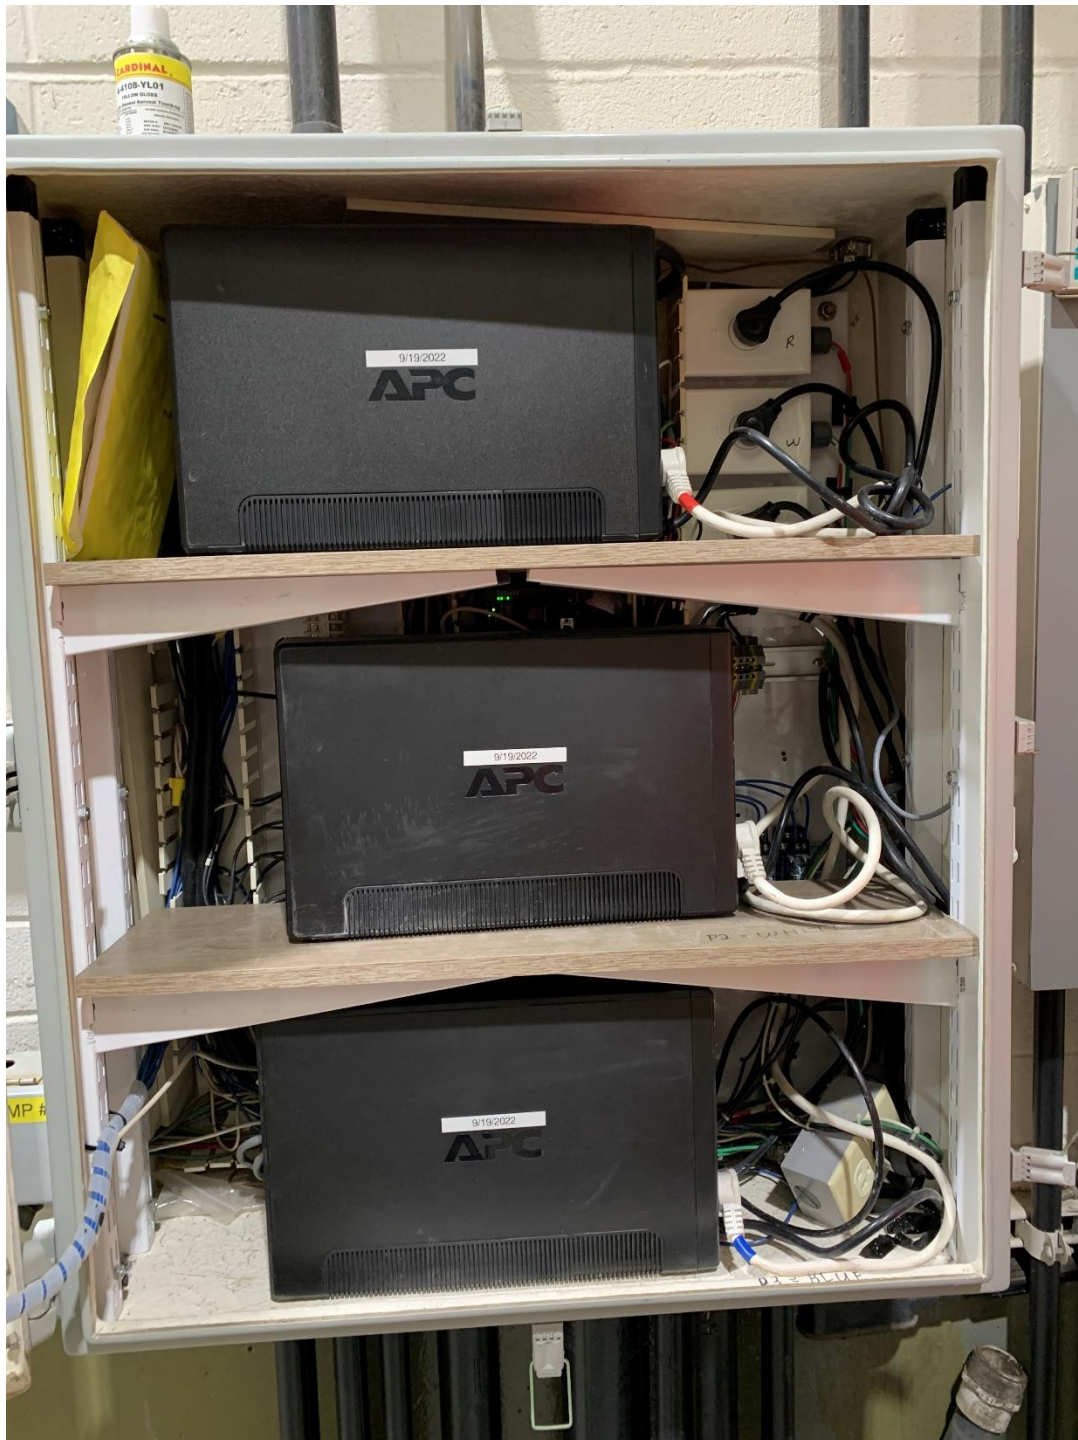
Figure 9. The three uninterruptible power supply boxes support the Facility's programmable logic controller during a power outage. EBDA last replaced these in September 2022. According to the O&M Manager, the power supply boxes are replaced every four years.

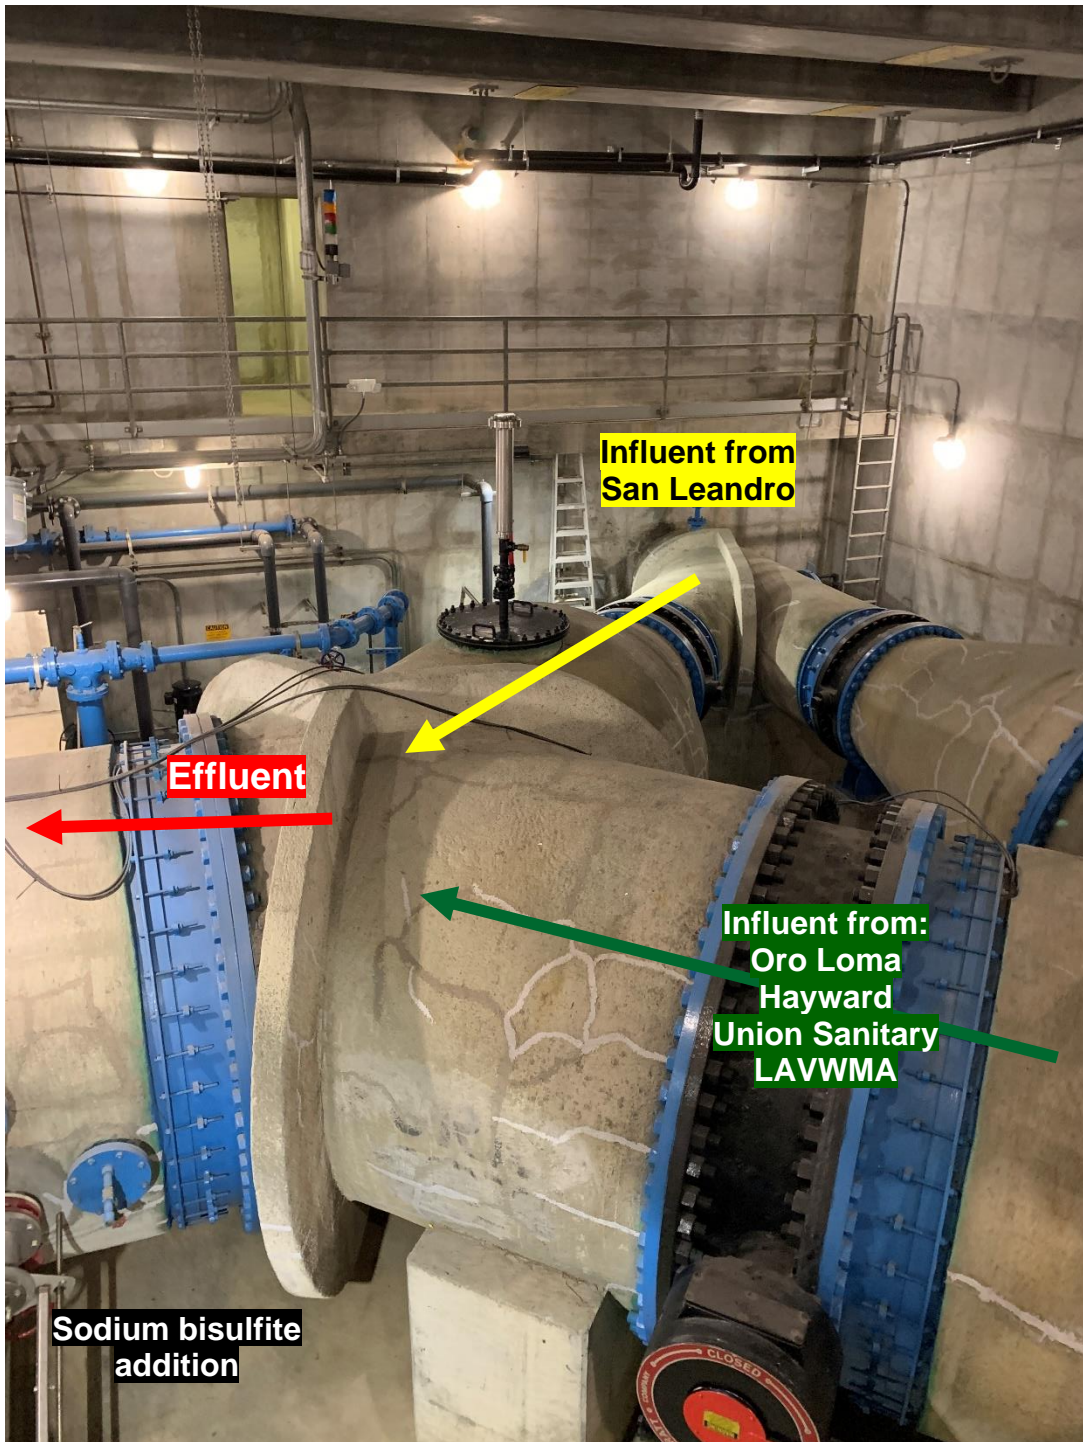
Figure 10. Influent from EBDA member agencies and LAVWMA is pumped to the Facility through converging force mains. Sodium bisulfite is injected into the converged influent.

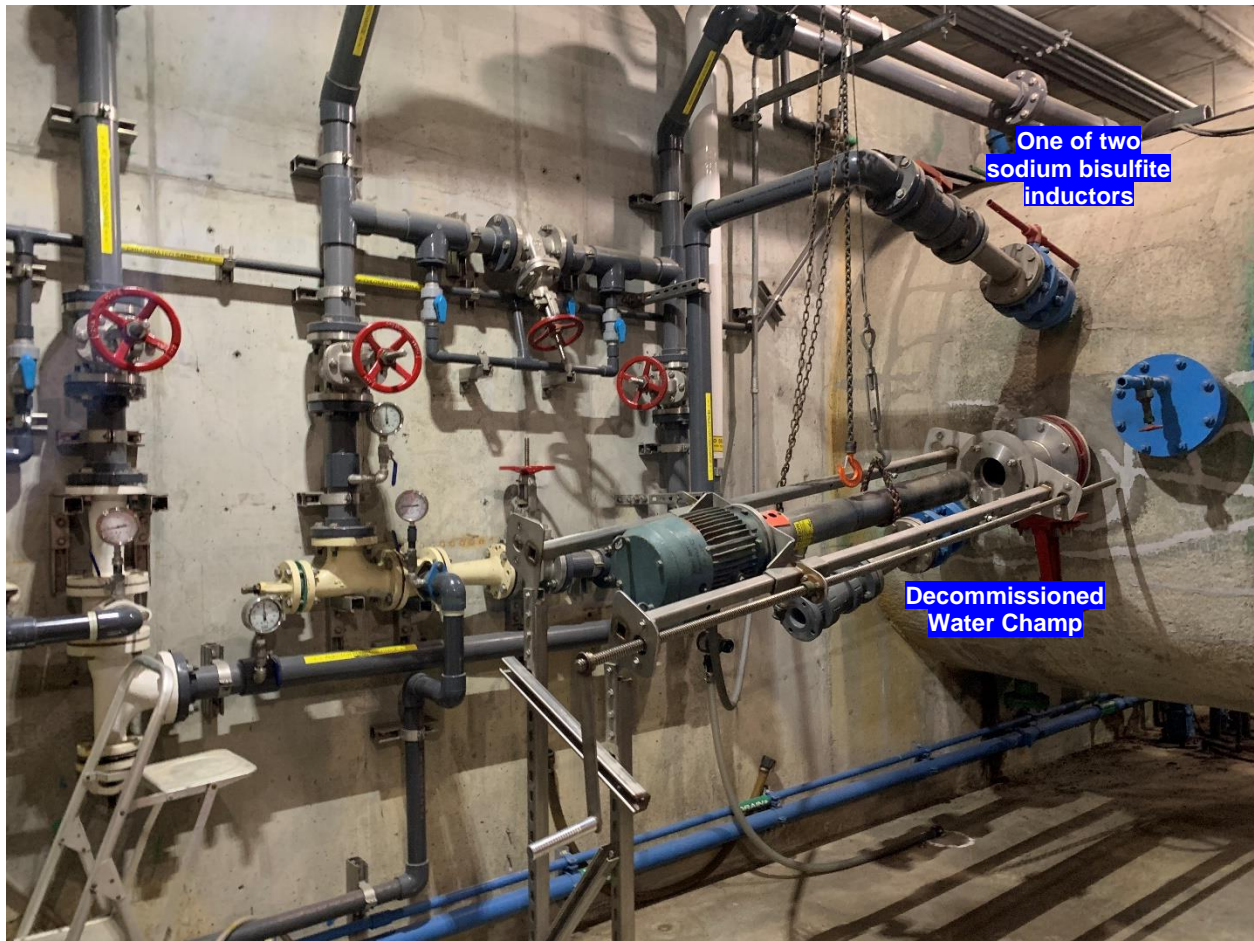
Figure 11. Sodium bisulfite is injected into effluent pipeline by two inductors immediately following the convergence of the two influent force mains. The decommissioned chemical mixer, or Water Champ, used to be EBDA's primary method of dechlorinating its effluent.

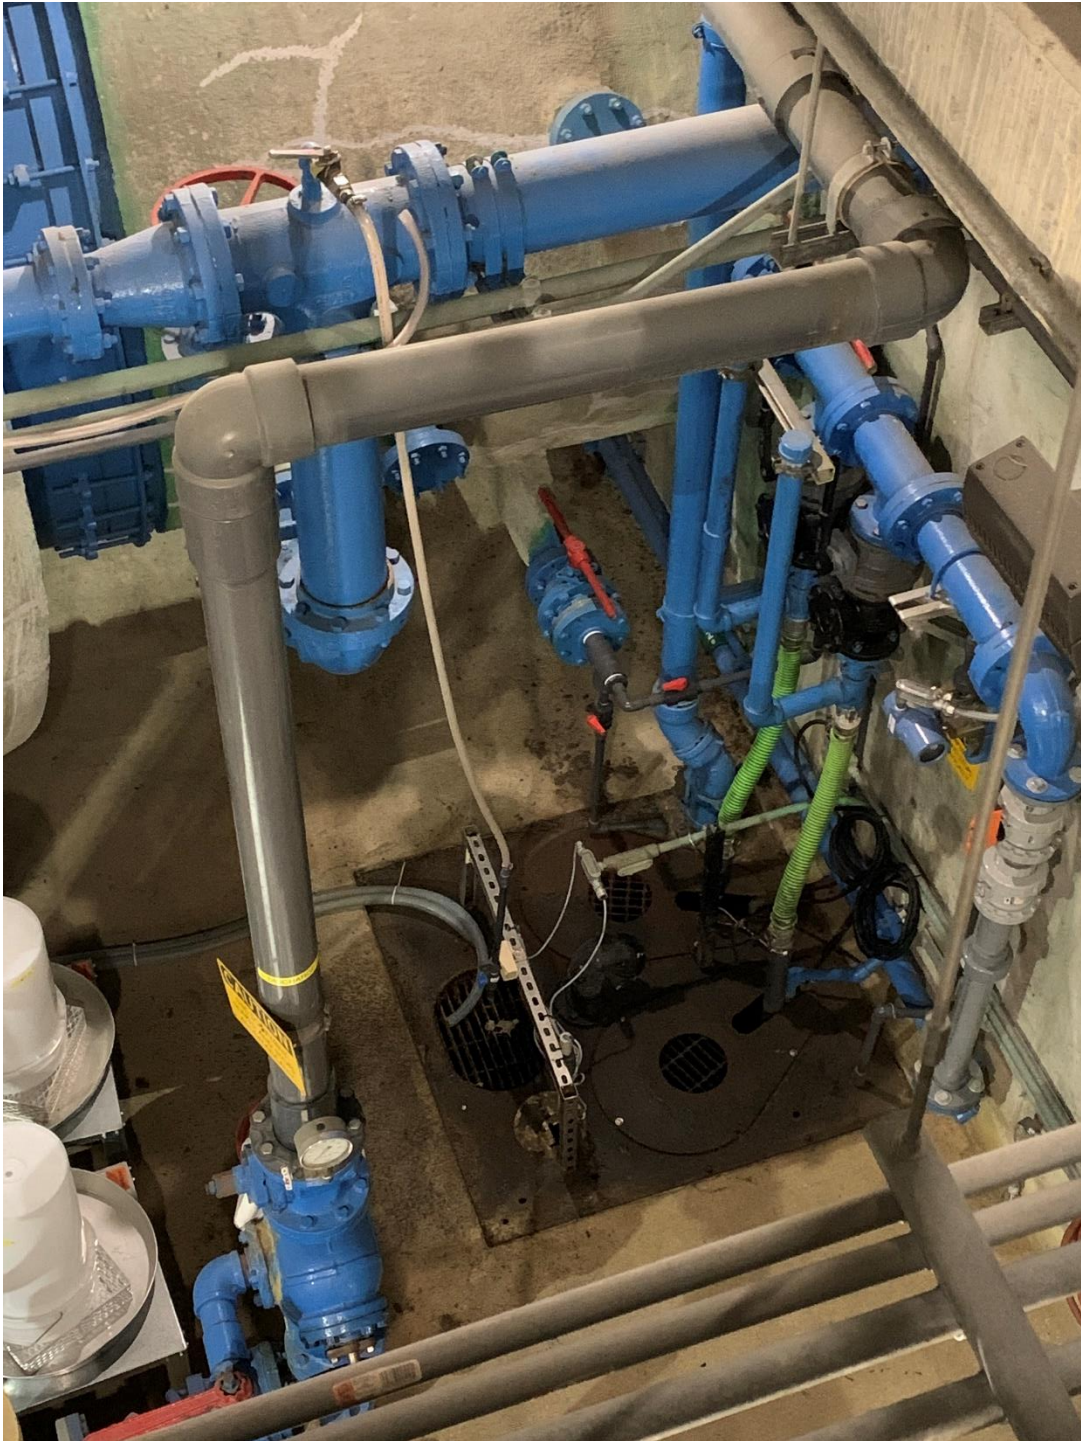
Figure 12. The bacteria sampling location just precedes the addition of sodium bisulfite.

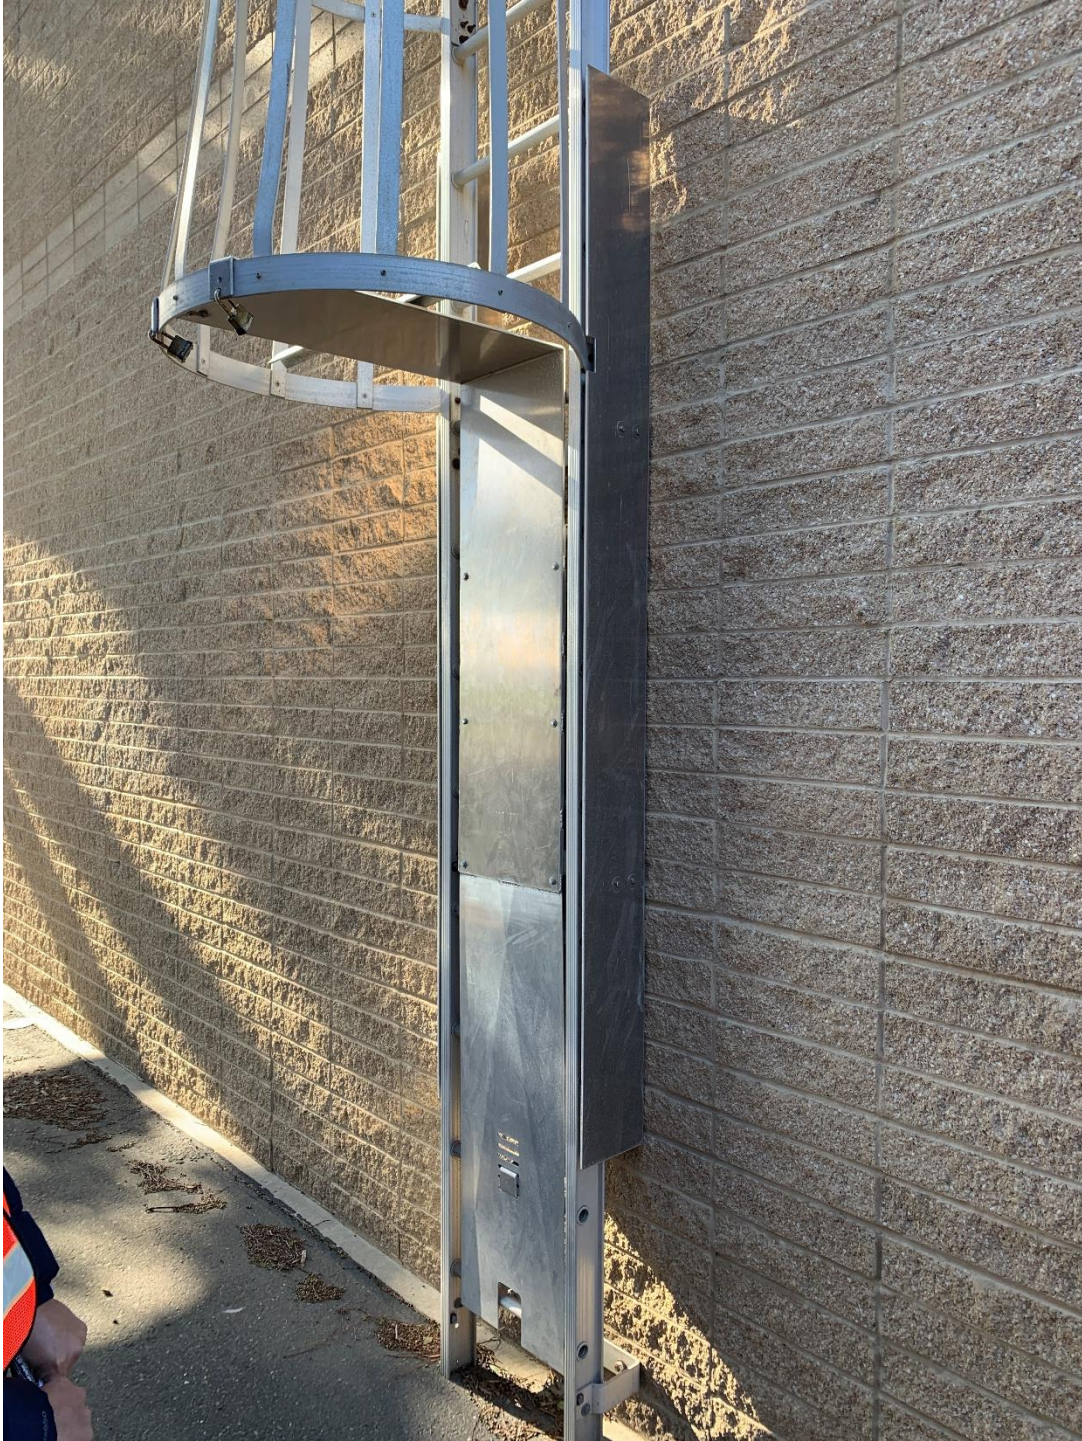
Figure 13. EBDA installed metal guards on the front and sides of the ladder to prevent people from climbing to the roof of the sodium bisulfite storage building after hours.
