OPERATIONS & MAINTENANCE COMMITTEE AGENDA

Tuesday, May 19, 2020

East Bay Dischargers Authority 2651 Grant Avenue, San Lorenzo, CA 94580

ITEM NO. <u>OM6</u> MAY 6, 2020 BYPASS AND MAY 12, 2020 RECYCLED WATER LEAK INCIDENT REPORTS

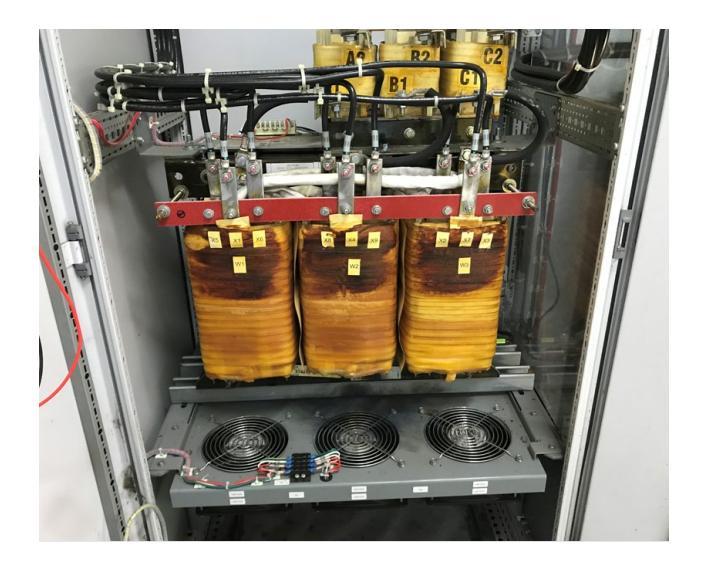
Effluent Pump No. 2 VFD Transformer

On April 29, 2020, USD notified EBDA that the VFD for Effluent Pump No. 2 blew a 250 Amp fuse. Rockwell Automation Field Service inspected the VFD on May 5, 2020. The Field Service Engineer determined that the center pole lower portion of the transformer was burned and needed to be replaced. EBDA staff is in the process of obtaining quotes for repair or replacement of the center pole of the transformer.

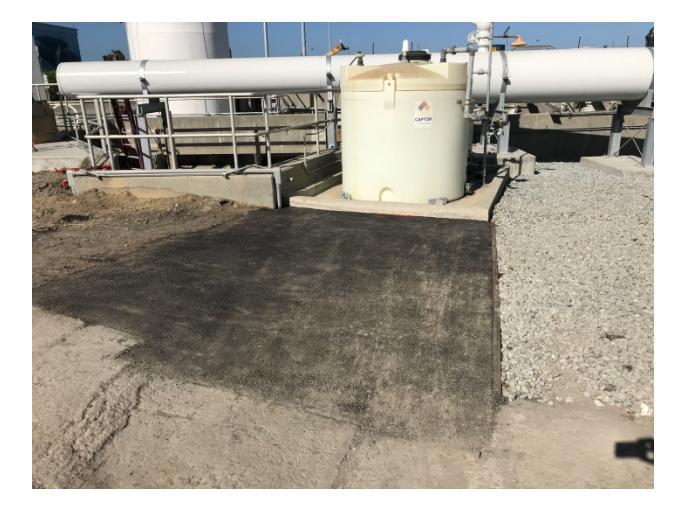
Captor Tank Access Pad

On April 22, 2020, the paving subcontractor for OLSD's Nutrient Optimization Project installed a Captor tank access pad at the OLEPS dechlorination system. Staff requested a quote to install a concrete pad, but it was deemed too expensive at \$8,688. The quote for the asphalt pad was \$2,147. The new asphalt pad will improve safety when working around the tank with a forklift. A safety orange water-filled barrier will be placed at the end of the pad closest to the tank to complete the project.

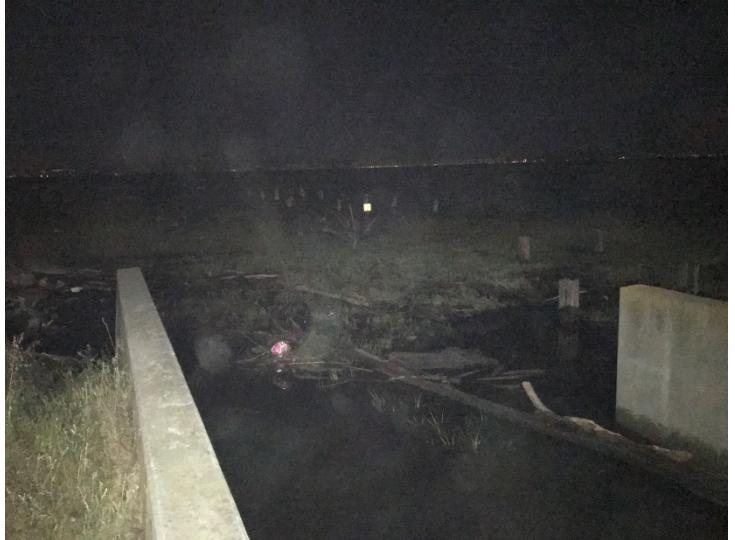
Figure 2 – Outfall shortly after the incident at approximately 00:09

Figure 2 is a photo of the outfall shortly after the incident. No sampling was conducted due to inability to access the discharge safely in the middle of the night.

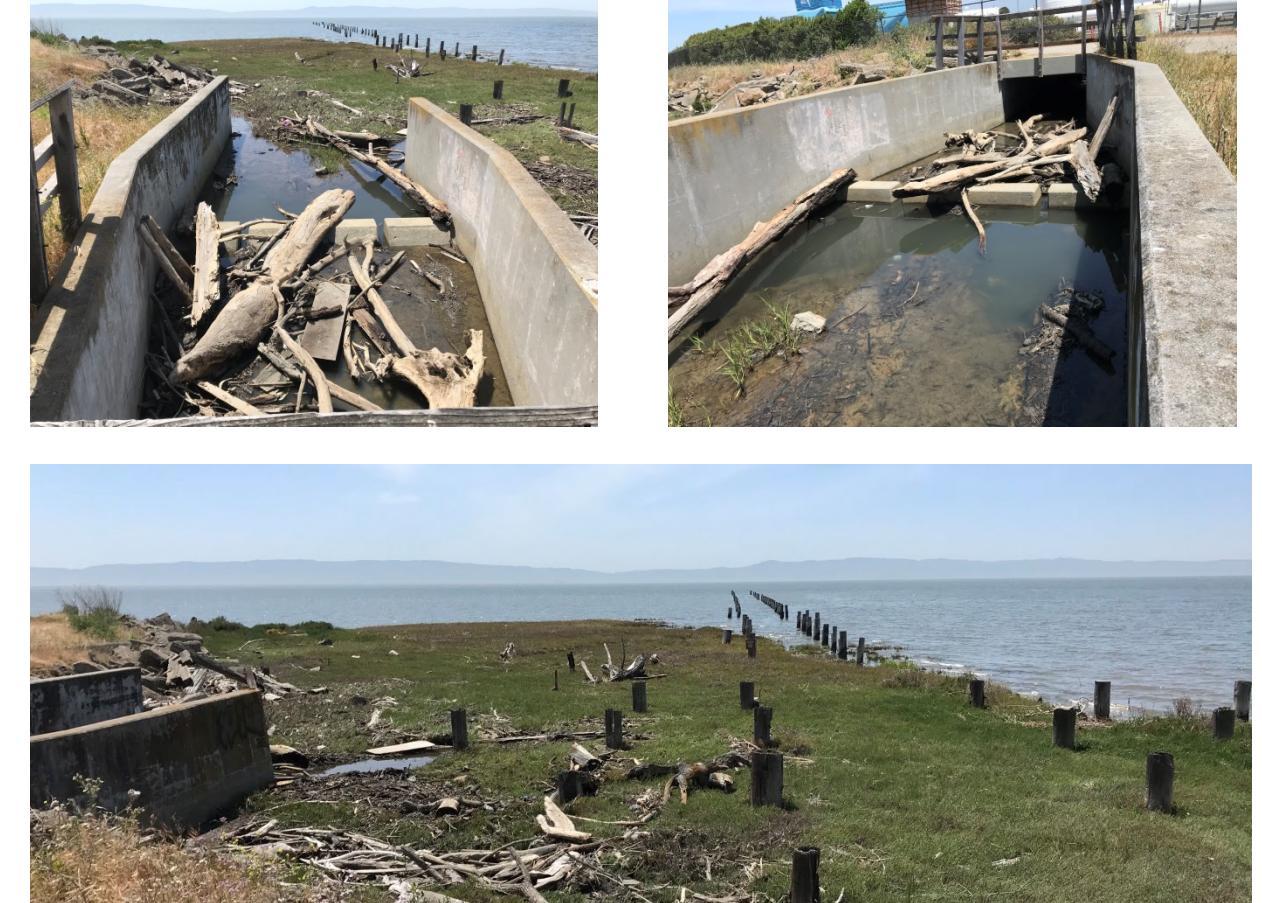
Figure 3 - Outfall the day following the incident at approximately 13:04

The photos in Figure 3 were taken the morning after the incident. As can be seen, significant debris is present in the outfall structure, which would have added to the mixing of the chlorinated effluent with the subsequent dechlorinated effluent with its extra Captor and the Bay water. High tide the night of the incident occurred at 12:29 am, adding to the mixing and dilution.

At the time visual inspections were completed the night of the incident (Figure 2) and the next day (Figure 3), no impacts were observed. Samples were not taken the following day due to the expectation that the discharge had been fully mixed and drawn out to open water overnight.

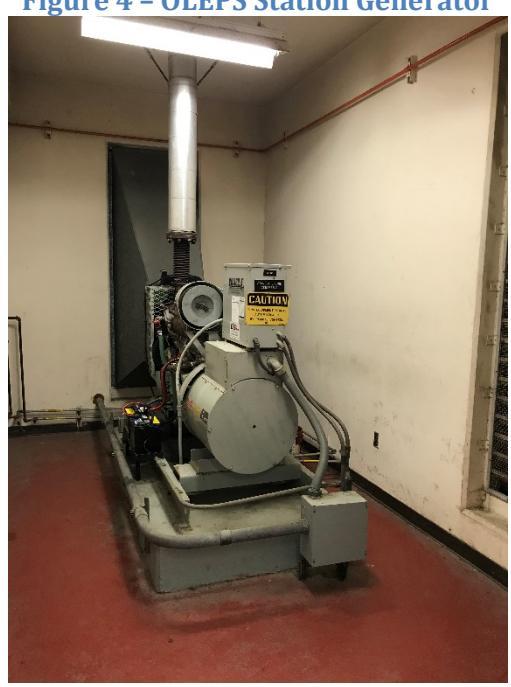
Figure 4 – OLEPS Station Generator

The OLEPS Station Generator is a Pavid Manufacturing 75kW standby diesel engine-driven standby generator (see Figure 4). Though it is approximately 40 years old, it has historically been very reliable. Due to its age, EBDA had initiated a station electrical upgrade, described in a subsequent section. OLSD staff continued to maintain and test the generator under contract to EBDA. Recent generator run logs indicating that the generator was run on a monthly basis are included as Attachment 8. The most recent successful test was May 4, 2020.

On May 5, 2020, staff identified a bad rectifier anode on the voltage regulator for the EBDA standby generator. An OLSD maintenance mechanic was running the generator late in the day when it stopped producing power. The maintenance mechanic, OLSD Maintenance Manager & the EBDA O&M Manager worked until approximately 16:45 to identify the issue. It was too late to try to source to part at that time, so it was ordered on the morning of May 6, 2020 for next day delivery. The rectifier order and packing slip are included as Attachment 9.

and assisted with the testing of that new system until late that day. On May 8, 2020 staff installed the repaired voltage regulator, ran the standby generator with no problems, and returned it to service.

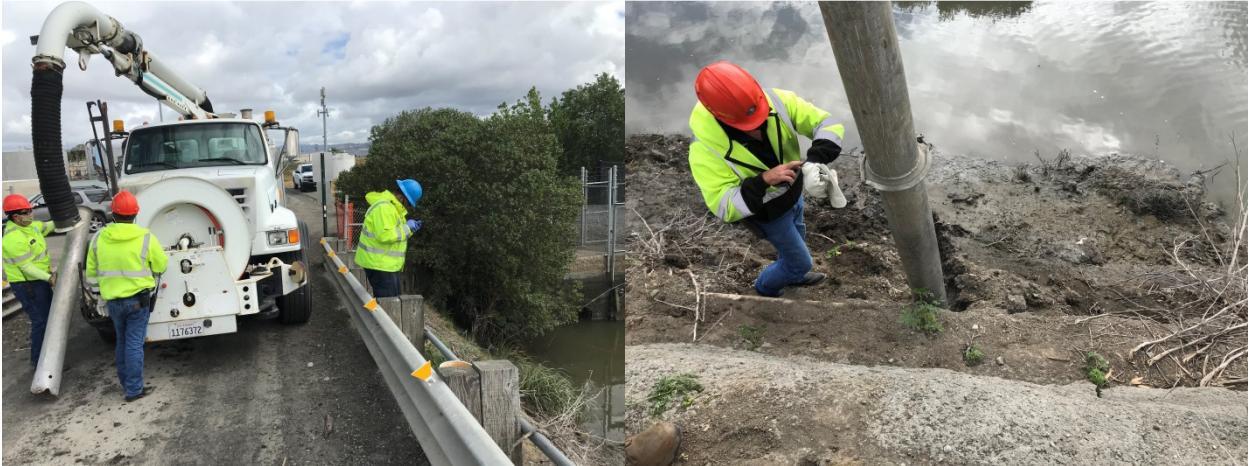
OLSD Vactor Crew At The Location Of The Leak

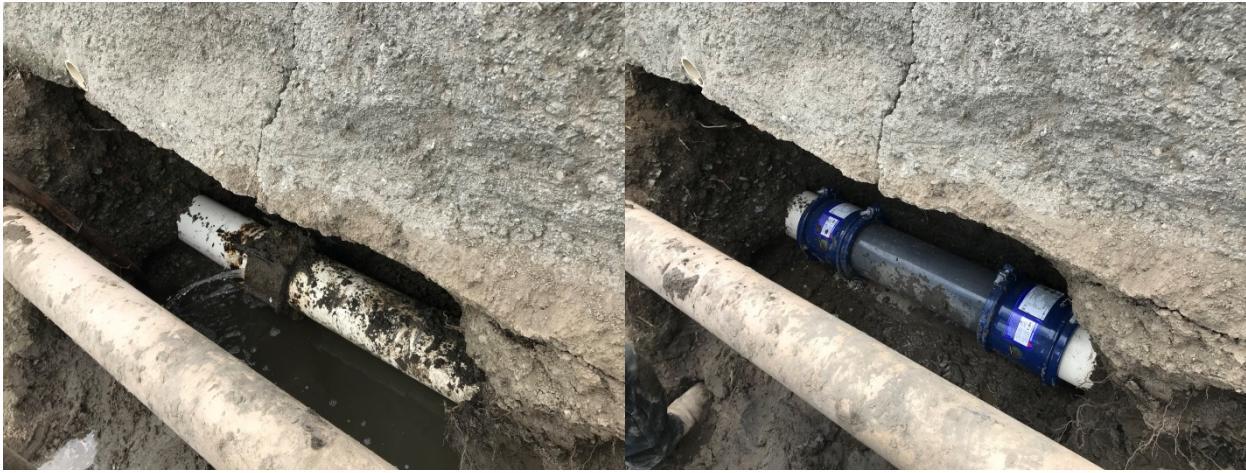
The cause of the leak was a failed coupling at the bridge. At this location, differential settling caused the pipeline to jut out, stressing the coupling. OLSD has hired a structural engineer to assess the conditions at the bridge and recommend improvements.

The Leak
