**ITEM NO. 12**

**OPERATIONS & MAINTENANCE COMMITTEE AGENDA**

**Tuesday, October 17, 2023**

**East Bay Dischargers Authority  
2651 Grant Avenue, San Lorenzo, CA**

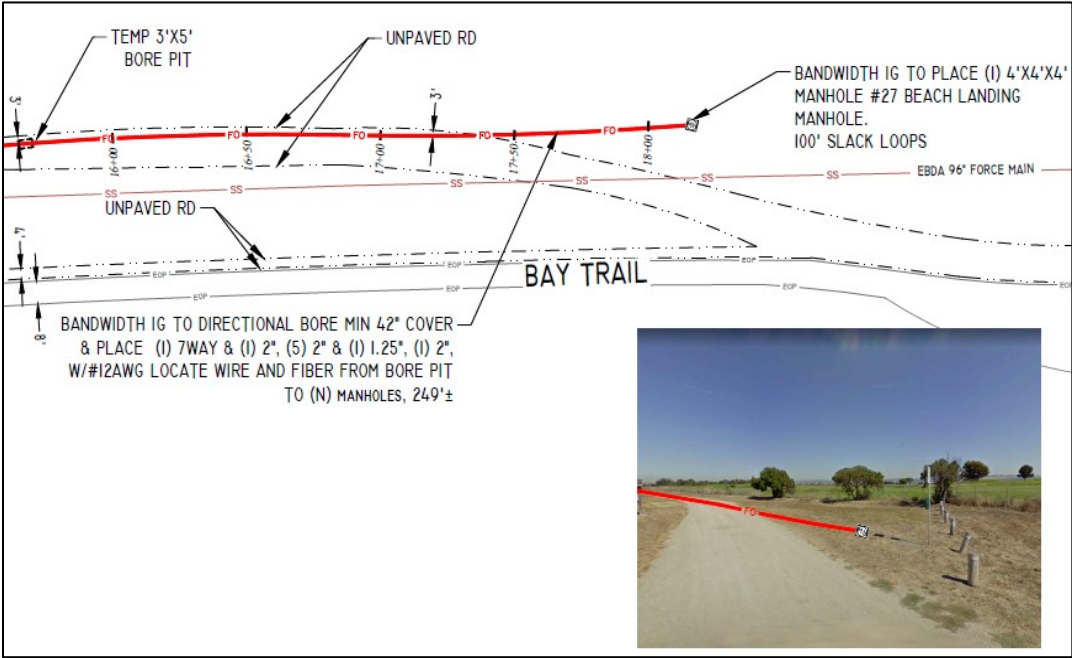
**Original Bandwidth Infrastructure Group Project Plans**

These plans have the EBDA 96-inch force main in the wrong location resulting in the Bandwidth manhole directly on top of the EBDA force main.

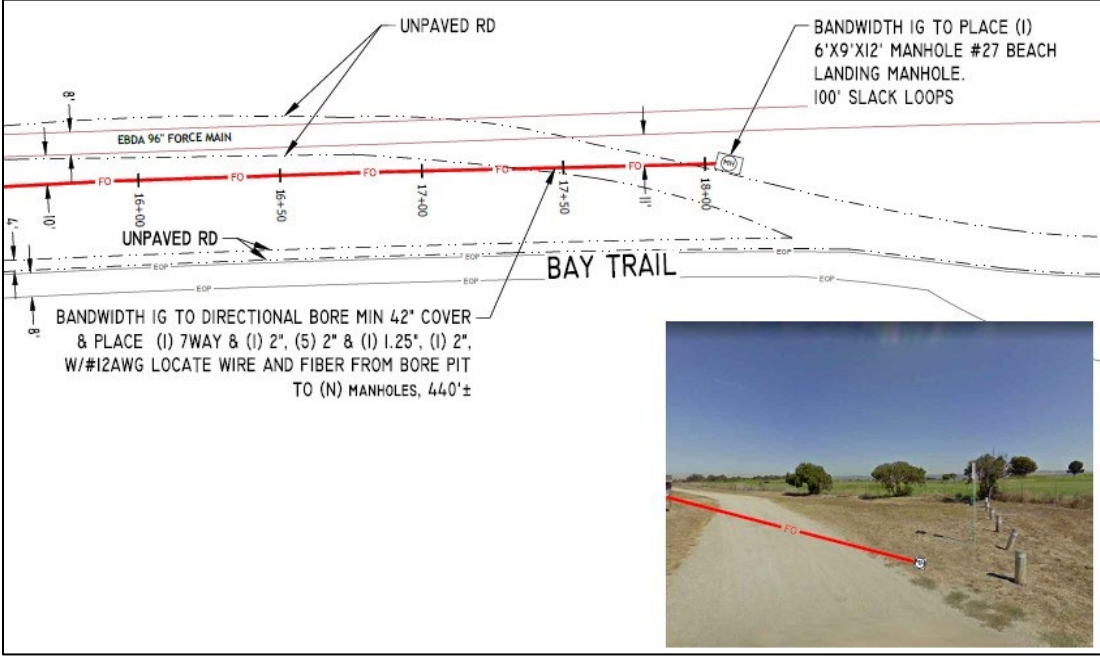
**Corrected Bandwidth Infrastructure Group Project Plans**

These plans have the EBDA 96-inch force main in the correct location. The force main and the fiber line in red switched positions, which eliminated the fiber line crossing the EBDA force main in this location.

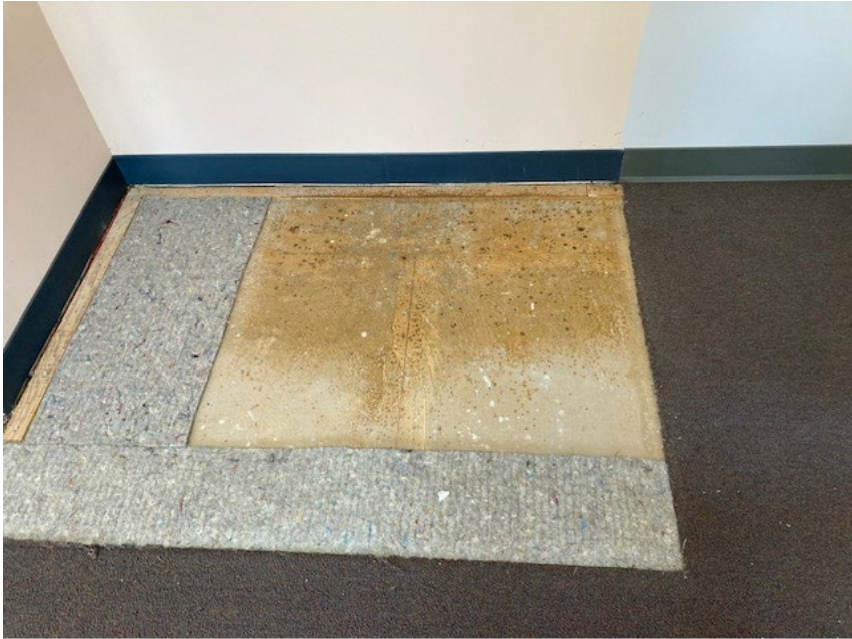
On September 25, 2023, EBDA began the next phase of the project to replace the aged carpet with laminate flooring and paint all interior walls. During the floor replacement, additional dry rot was found in one area and mold was found in another area (see photo on the following page). The dry rot was repaired and the mold was removed. The evidence of mold prompted staff to evaluate air flow in the building and basement. Based on review of the building as-built plans, it appears that there were additional vents under the building when it was initially constructed. At some point in the past, these vents were covered over. Staff has engaged EBDA's HVAC contractor, B.A. Morrison to look at the area under the building to evaluate the need to install additional vents and/or a fan that is controlled automatically with a moisture sensor. B.A. Morrison is scheduled to inspect the building on October 13<sup>th</sup>.

**Mold Identified in the Floor under the Plan Drawers**

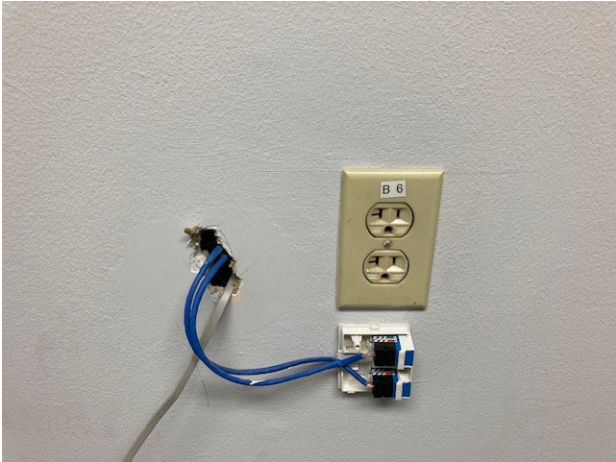
**Wiring Before**

As noted above, staff is moving forward with electrical improvements while painting is being conducted and carpet has been removed. In particular, wiring issues in several offices have been corrected and new electrical plates installed to improve safety and cosmetics (see photos below and on the following page). In addition, it has been determined that there are electrical code issues with the wiring through the lobby of the building, which was originally set up for multiple work stations. Staff has engaged EBDA's electrical and instrumentation contractor, Calcon, to perform the wiring and electrical upgrades to bring the building up to code.

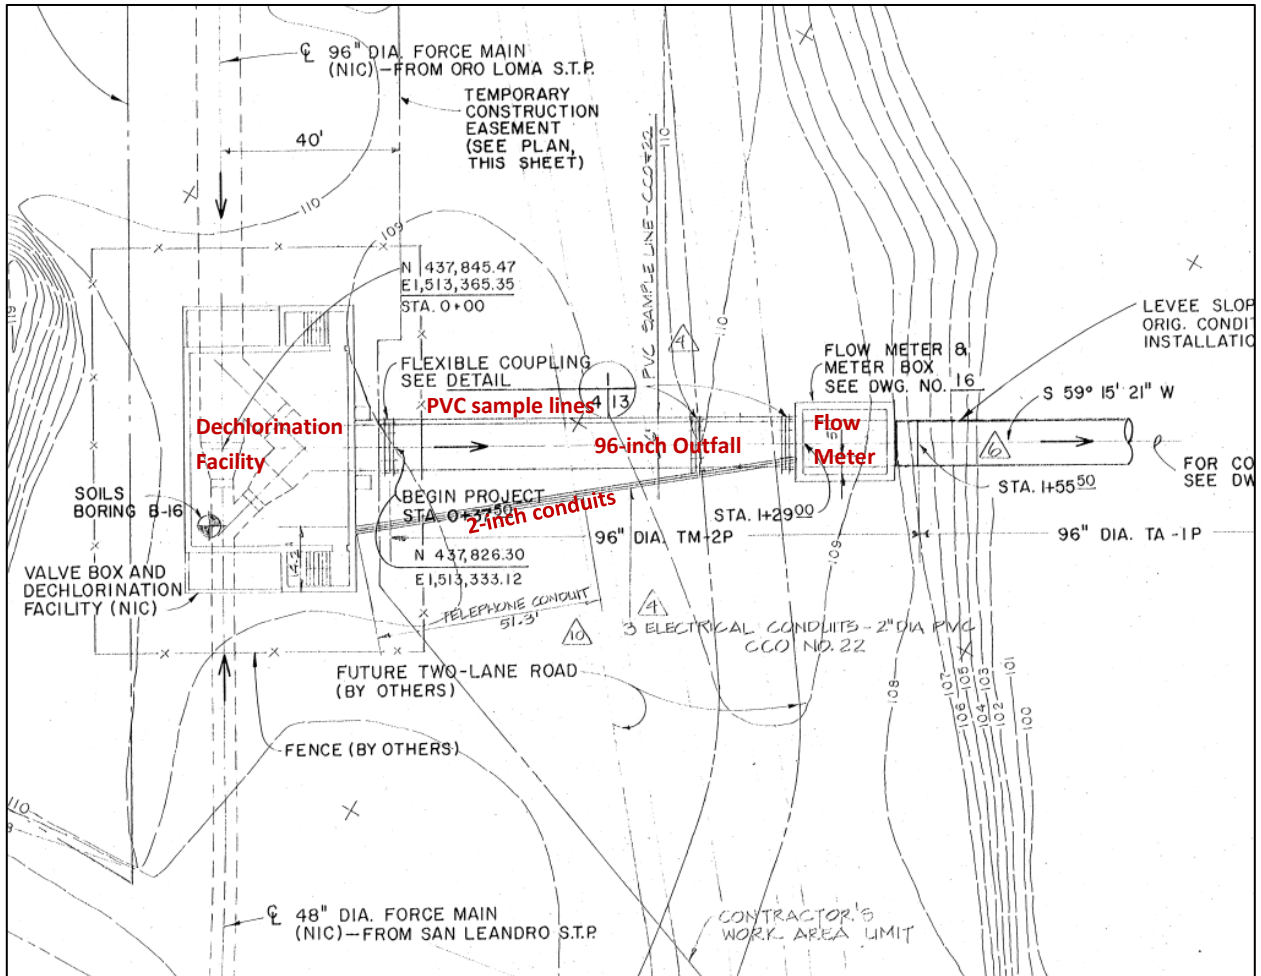
**Figure 1** – Excerpt from EBDA record drawings for the 96-inch Outfall Pipeline, Drawing No. 4. The Marina Dechlorination Facility to the left and the 96-inch Outfall Pipeline Flow Meter and Meter Box to the right. The length of the 96-inch Outfall Pipeline between the two structures is 95.5 feet.

Note the plan view location of 2-inch electrical and instrumentation conduits and 1-½ to 2-inch PVC sample lines between the Dechlorination Facility and Flow Meter and Meter Box. All conduits and pipes between the Dechlorination Facility and Flow Meter and Meter Box must be fully accounted for and potholed for accurate location and depth for HDD bore path design (see Figure 3).

5. Every electrical and instrumentation conduit and PVC sample line between the Marina Dechlorination Facility and the 96-inch Outfall Flow Meter and Meter Box (see Figure 1) must be:

- a. accounted for;
  - b. potholed; and
  - c. accurately located.

Once accurately located the HDD bore path must maintain a minimum of 5 feet of clearance from each conduit as well as 5 feet of clearance from the 96-inch Outfall Pipeline and with a minimum of 6 feet of cover (for a 12-to-14-inch reamed bore hole diameter).

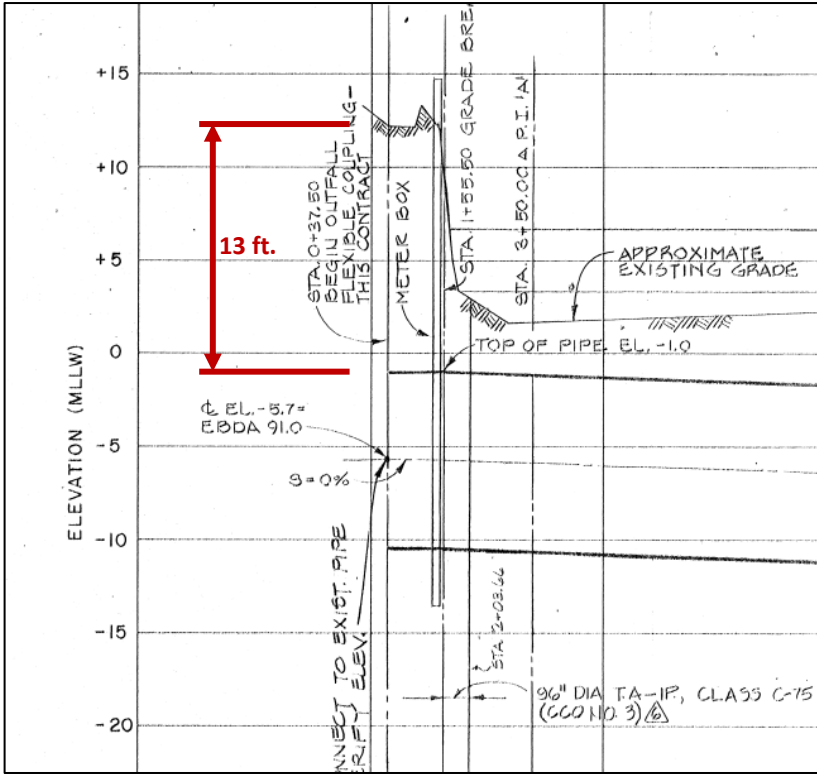
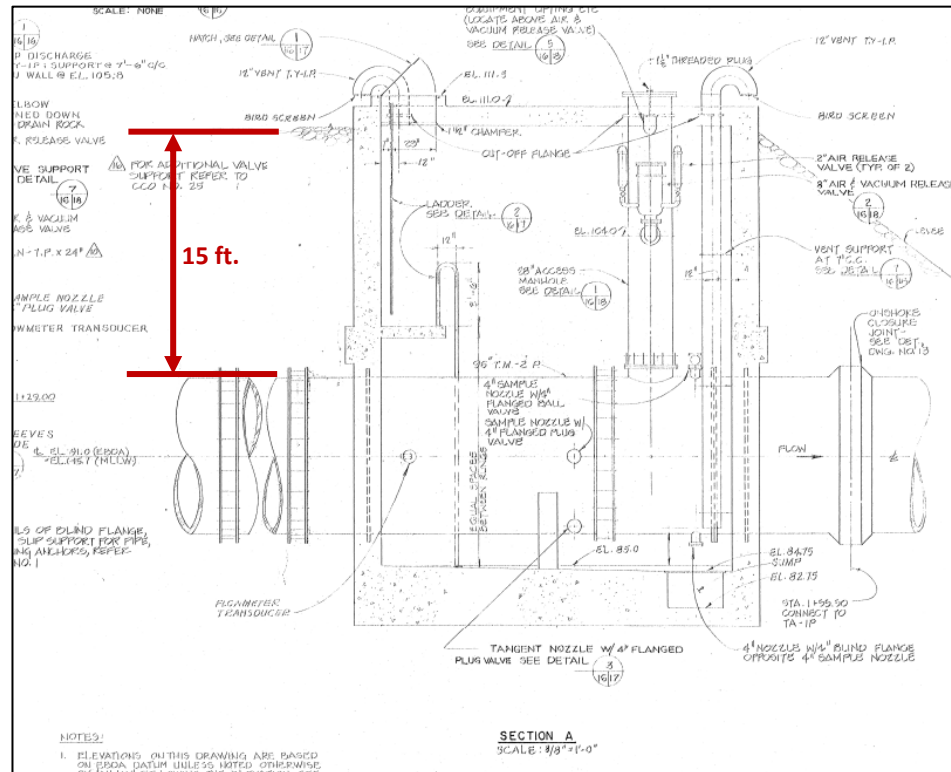
From EBDA Outfall Pipeline record drawings No. 5 and No. 16

**Figure 2** – The depth of cover on the 96-inch Outfall Pipeline from record drawings varies from 13 feet at the Marina Dechlorination Facility (upper section) to 15 feet at the Flow Meter/Meter Box (lower section). Depth of cover at crossing to be confirmed by potholing.

This upper HDD bore path window may close as a function of the pot holed depths of electrical and instrumentation conduits and PVC sample lines.

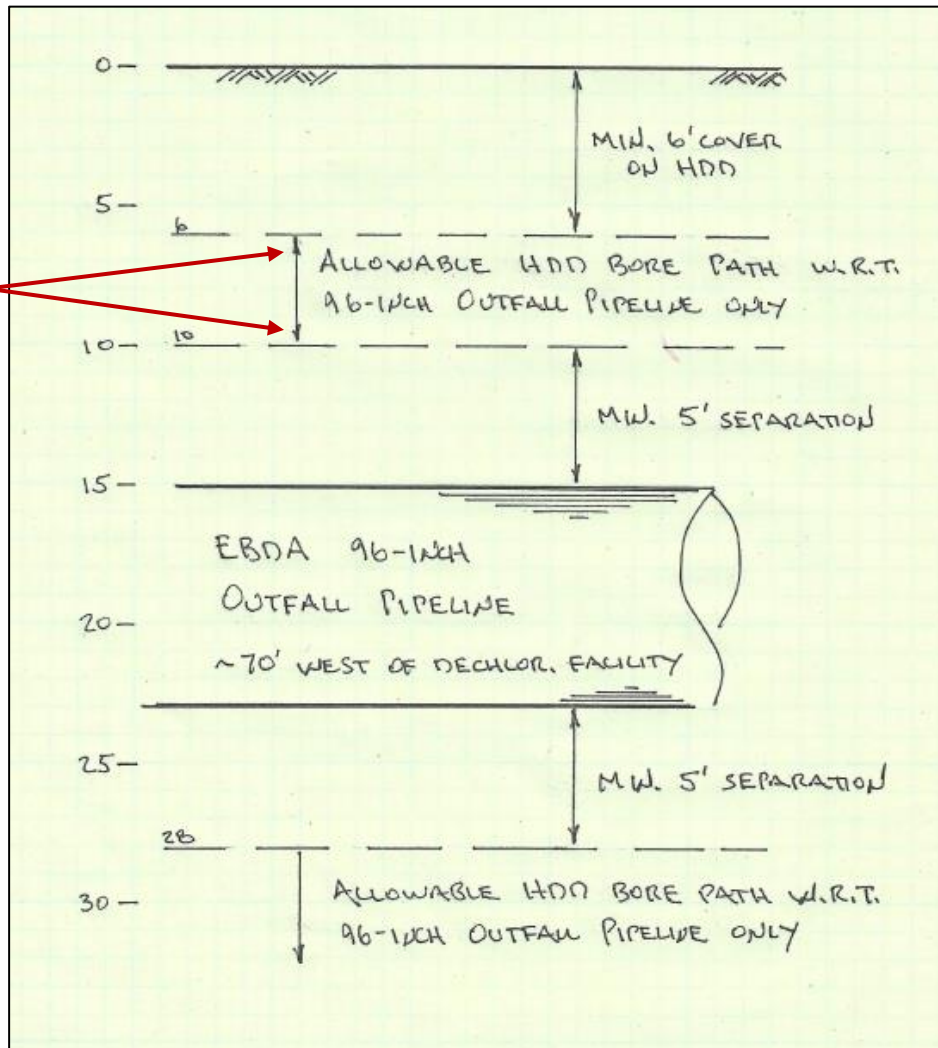
As shown in Figure 3, the available HDD bore path above the 96-inch Outfall Pipeline is very limited with respect to the 96-inch Outfall Pipeline only. When the multiple 2 inch electrical and instrumentation conduits and 1-½ to 2-inch PVC sample lines are fully accounted for and pot holed for accurate depths they will need to be added to this or similar section. Given the minimum depths of cover and minimum clearances from crossing utilities specified in Bandwidth IG's plans Construction Note 5 (see Figure B), it may be impossible to directional drill above the 96-inch Outfall Pipeline. Bandwidth IG should provide a bore profile for final review (similar to sheet BP-1 for the A.C.F.C. Creek crossing) for crossing EBDA's 96-inch Outfall Pipeline and associated 2-inch electrical and instrumentation conduits and 1-½ to 2-inch PVC sample lines.

**Figure 3** – Schematic section at 96-inch Outfall Pipeline crossing approximately 70 feet west of the Dechlorination Facility illustrating the very narrow allowable HDD bore path above the Outfall Pipeline (only 4 feet). Assumes 12 to 14-inch reamed HDD bore hole and the minimum depth of cover and minimum clearance from crossing utilities from Bandwidth IG plans Construction Note 5 (see Figure B).

Note that this schematic section does not include the depths of multiple electrical and instrumentation conduits and PVC sample lines between the Dechlorination Facility and 96-inch Outfall Pipeline Flow Meter/Meter Box as shown in Figure 1. Once accurately accounted for and located these conduits need to be added to this evaluation of allowable HDD bore path depth.
