OPERATIONS & MAINTENANCE COMMITTEE AGENDA

Wednesday, February 19, 2025

**East Bay Dischargers Authority
2651 Grant Avenue, San Lorenzo, CA**

To:	Howard Cin East Bay Dischargers Authority (EBDA)	Date:	February 7, 2025
From:	Dave Mathy DCM Consulting, Inc.	File:	No. 431
Subject:	East Bay Regional Park District (EBRPD) Hayward Marsh Restoration – Construction Access Route Crossing East Bay Dischargers Authority (EBDA) 60-inch Force Main Pipeline Hayward, California

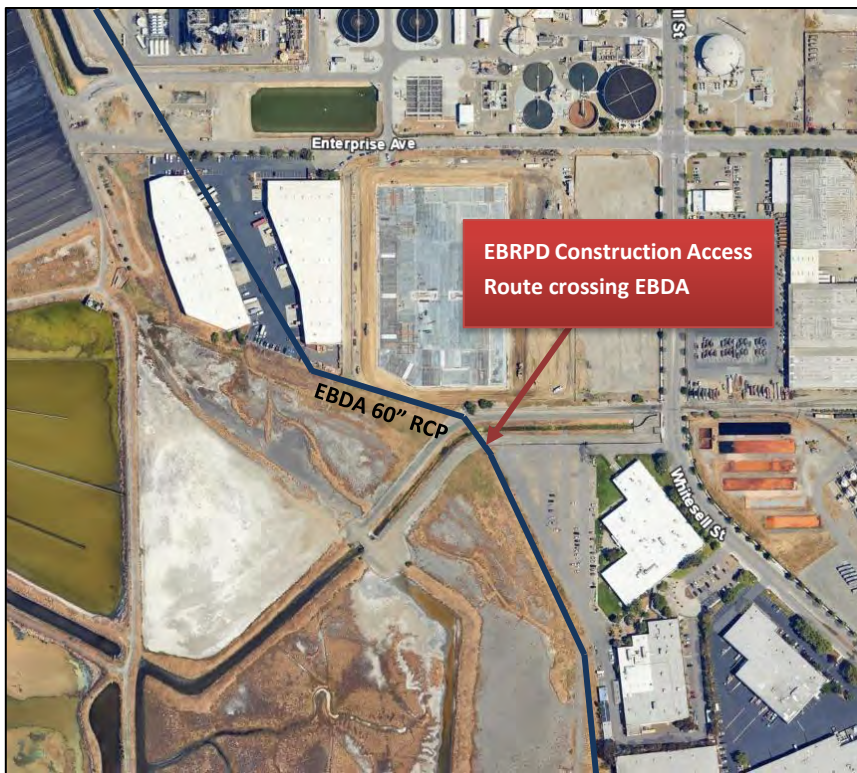
Figure A – Location of EBRPD Construction Access Route to Whitesell St. crossing over EBDA’s 60-inch RCP force main pipeline. The Construction Access Route will be on the south side of the drainage channel west of Whitesell St.

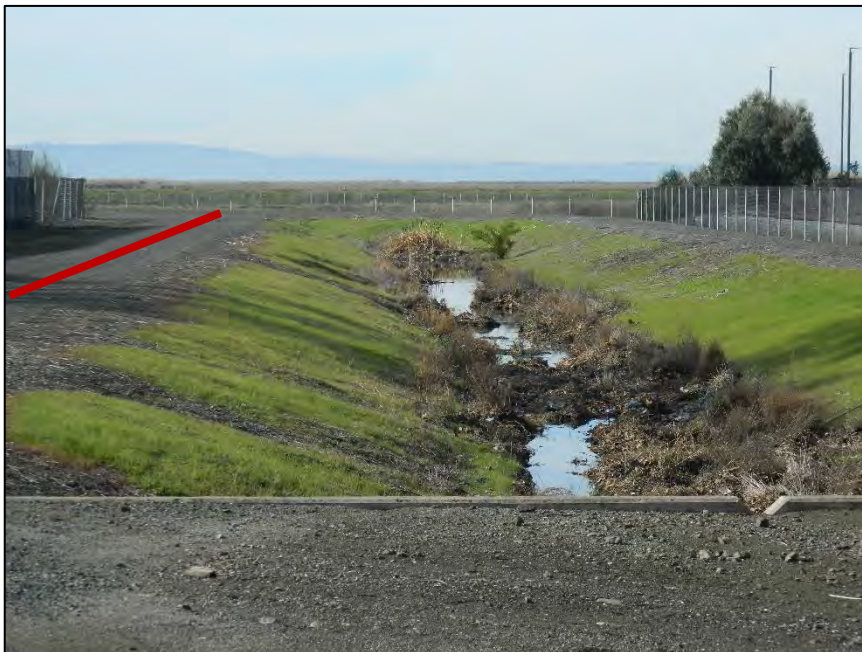
Photo 1 – View of drainage channel from Whitesell St. looking west. This channel was constructed after the EBDA pipeline, most likely resulting in locally reduced cover on the RCP force main. The EBRPD Construction Access Route will be on the south side berm of the drainage channel (photo left, red line). To photo right are the north side berm and railroad spur tracks.

The thickness of berm fill above natural grade at the EBDA crossing (i.e., the grade in 1977 at the time of EBDA pipeline construction) is approx. 3 feet.

Photo taken on January 2, 2025.

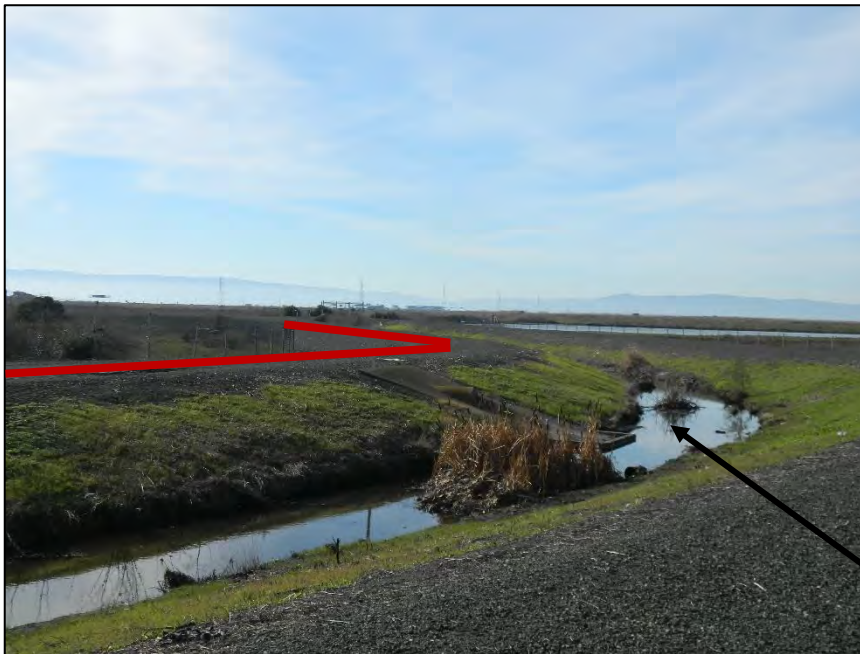
Photo 2 – View of drainage channel from railroad spur looking southwest. This channel was built after the EBDA pipeline, most likely resulting in locally reduced cover on the 60-inch RCP force main.

Note that the top of the EBDA pipeline is at sea level (i.e., El. 0 in 1977).

Photo taken on January 2, 2025.

Approx EBDA 60-inch RCP crossing the drainage channel

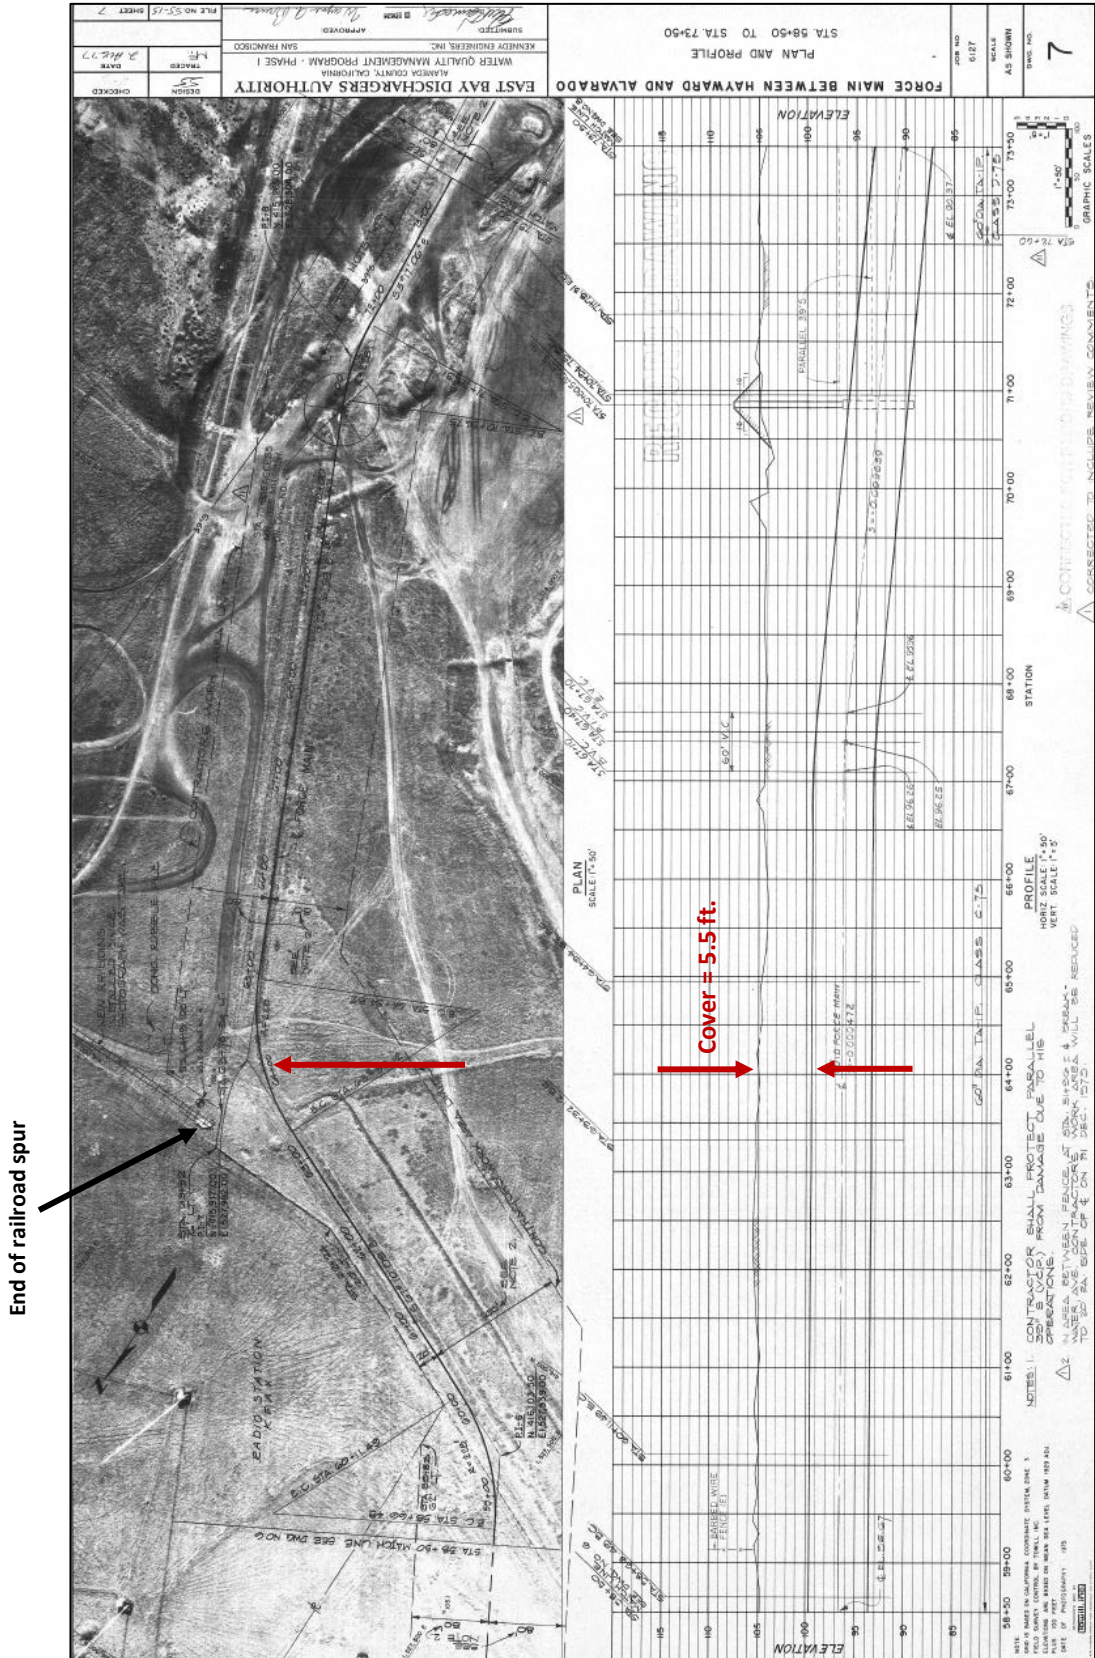
The cover on the EBDA 60-inch RCP force main pipeline as shown in the 1977 Record Drawings was about 5 feet (see Figure 3). This is the cover thickness in the presently undisturbed marsh area south of the drainage channel shown in Figure A and Figures 1 and 2.

1. At the crossing location the depth of cover on the EBDA 60-inch RCP force main pipeline as depicted in the 1977 Record Drawings (Figure 3) is 5 feet. With construction of the drainage channel shown in Photos 1 and 2 and berm construction on the north and south sides of the channel in about 1980 to 1982, the depth of cover on the EBDA 60-inch RCP at the drainage channel raised berms is now approximately 8 feet. Assuming that all wetlands restoration construction traffic follows the south side berm of the drainage channel and conforms to H20 loading (i.e., street/highway legal), the applied live loading on the EBDA 60-inch RCP with 8 feet of cover will be less than 1 psi.

Figure 3 – EBDA 60-inch RCP Force Main, 1977 plan and profile at the EBRPD construction access road crossing.
 Note, cover on the pipeline is approx. 5.5 feet in 1977. Note that the drainage channel does not show up on this plan and profile as it was extended to Whitesell St between 1980 and 1982.

Ground Surface Elevation, 1977 = El. 5.
Datum is NGVD 1929.
For current NAVD 1988 Elevation add 2.76 ft.

- b. Verify the existing pipeline top of pipe elevation and cover depth at the south berm, presently assumed at 8 feet. Cover depth of less than 8 feet will require reevaluation of the conclusions and recommendations of this technical memorandum.

- c. Determine the existing pipeline top of pipe elevation and depth of cover within the drainage channel at the toe of the south side berm.
3. Limit construction traffic on the access route to rubber-tired vehicles (e.g., transfer trucks) conforming to H20 highway and street legal loading and track-mounted construction equipment to a track contact pressure of less than 10 psi.

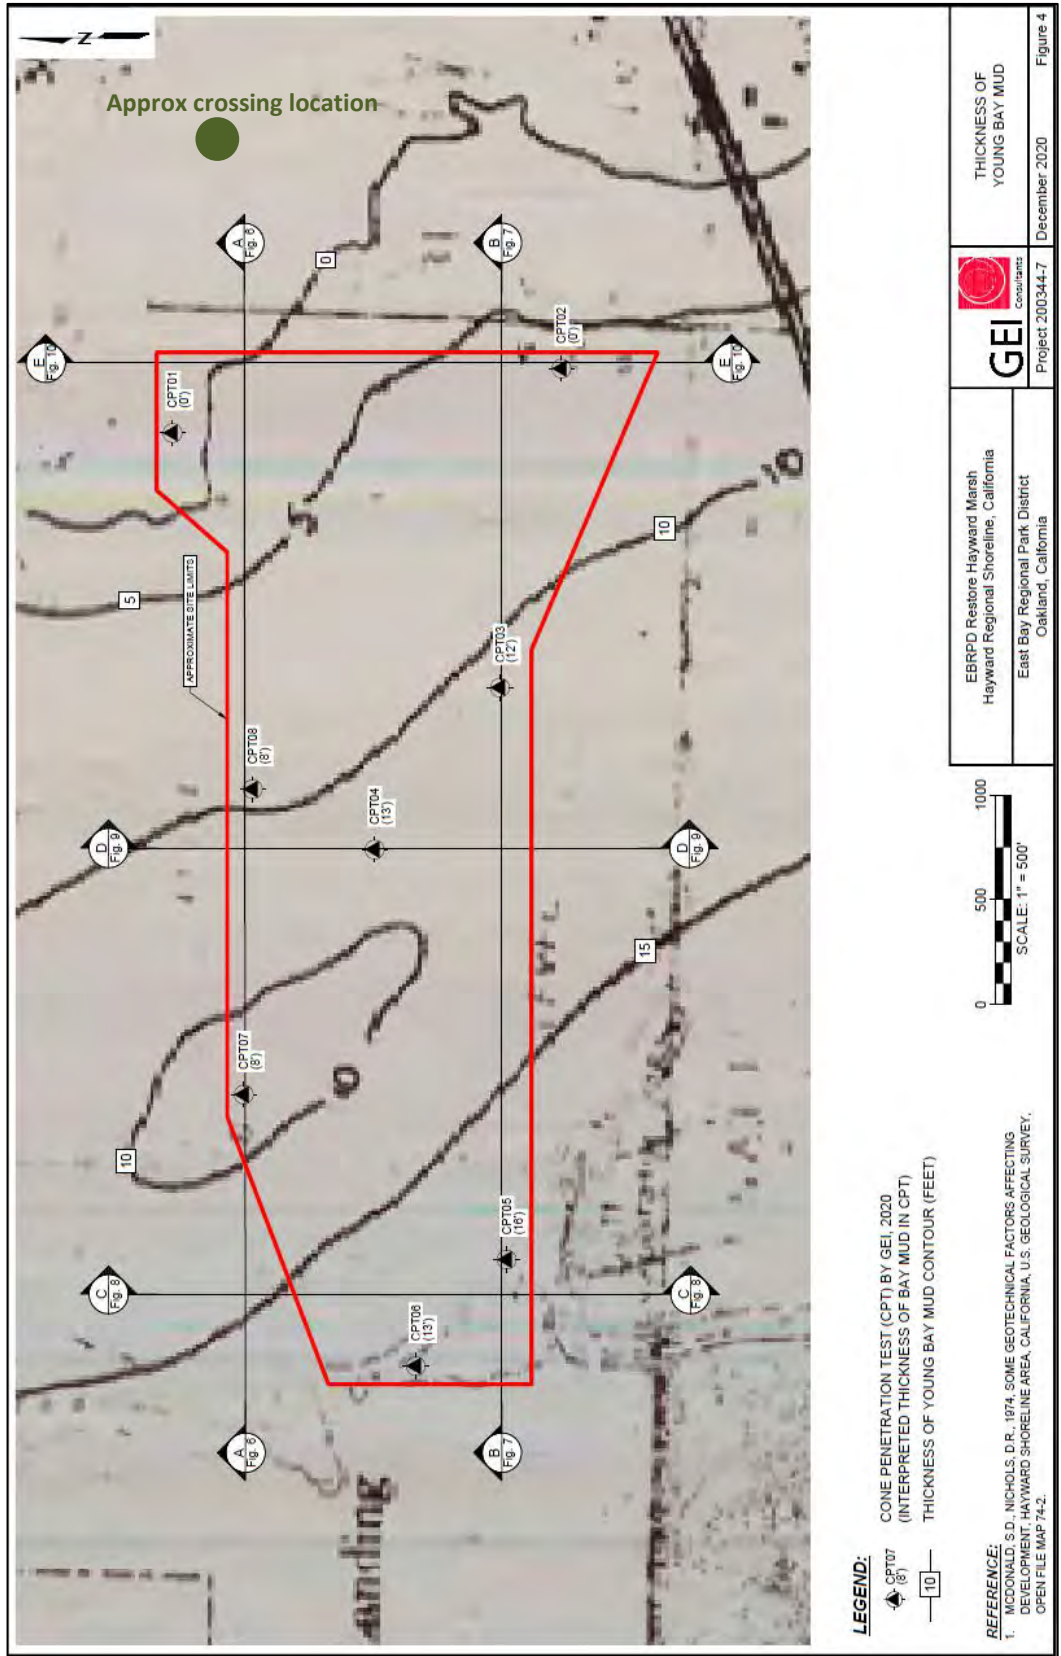
Figure 4 – GEI exploration map with Young Bay Mud Thickness Contours

Note the crossing location, shown in green, is upgradient (east) of the Young Bay Mud

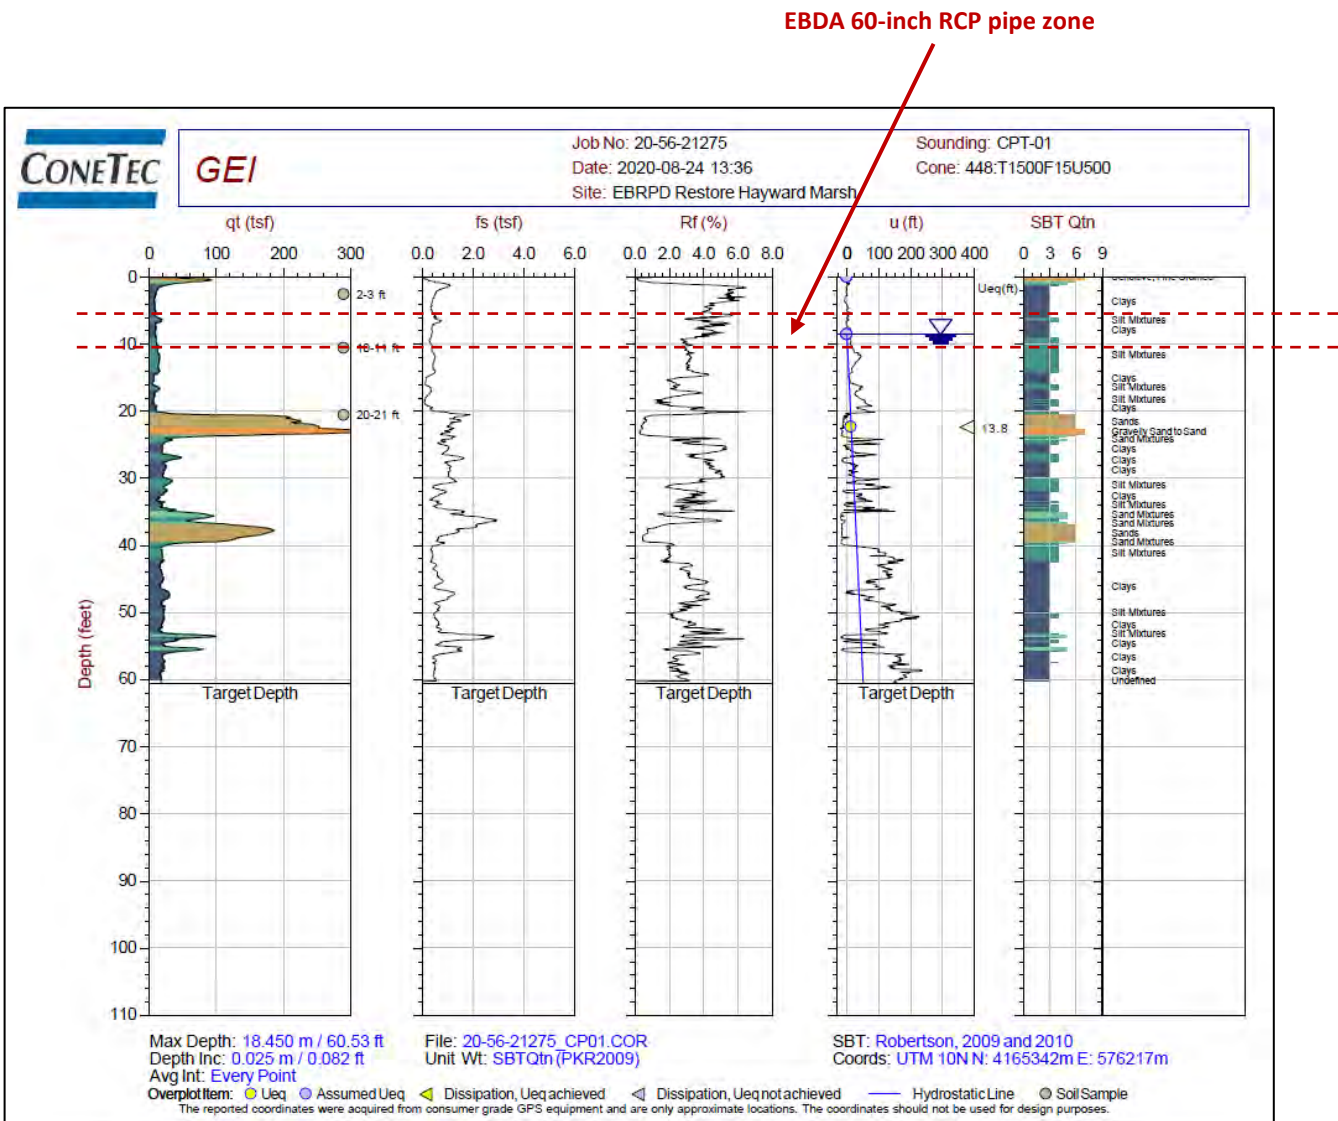
Figure 5 – Plot of CPT 01 by GEI, soil type at and below the invert depth of the EBDA 60-inch RCP force main are silt mixtures and clays

CPT 01 is approximately 1,400 feet west of the EBDA 60-inch RCP force main pipeline and EBRPD Construction Access Route crossing.

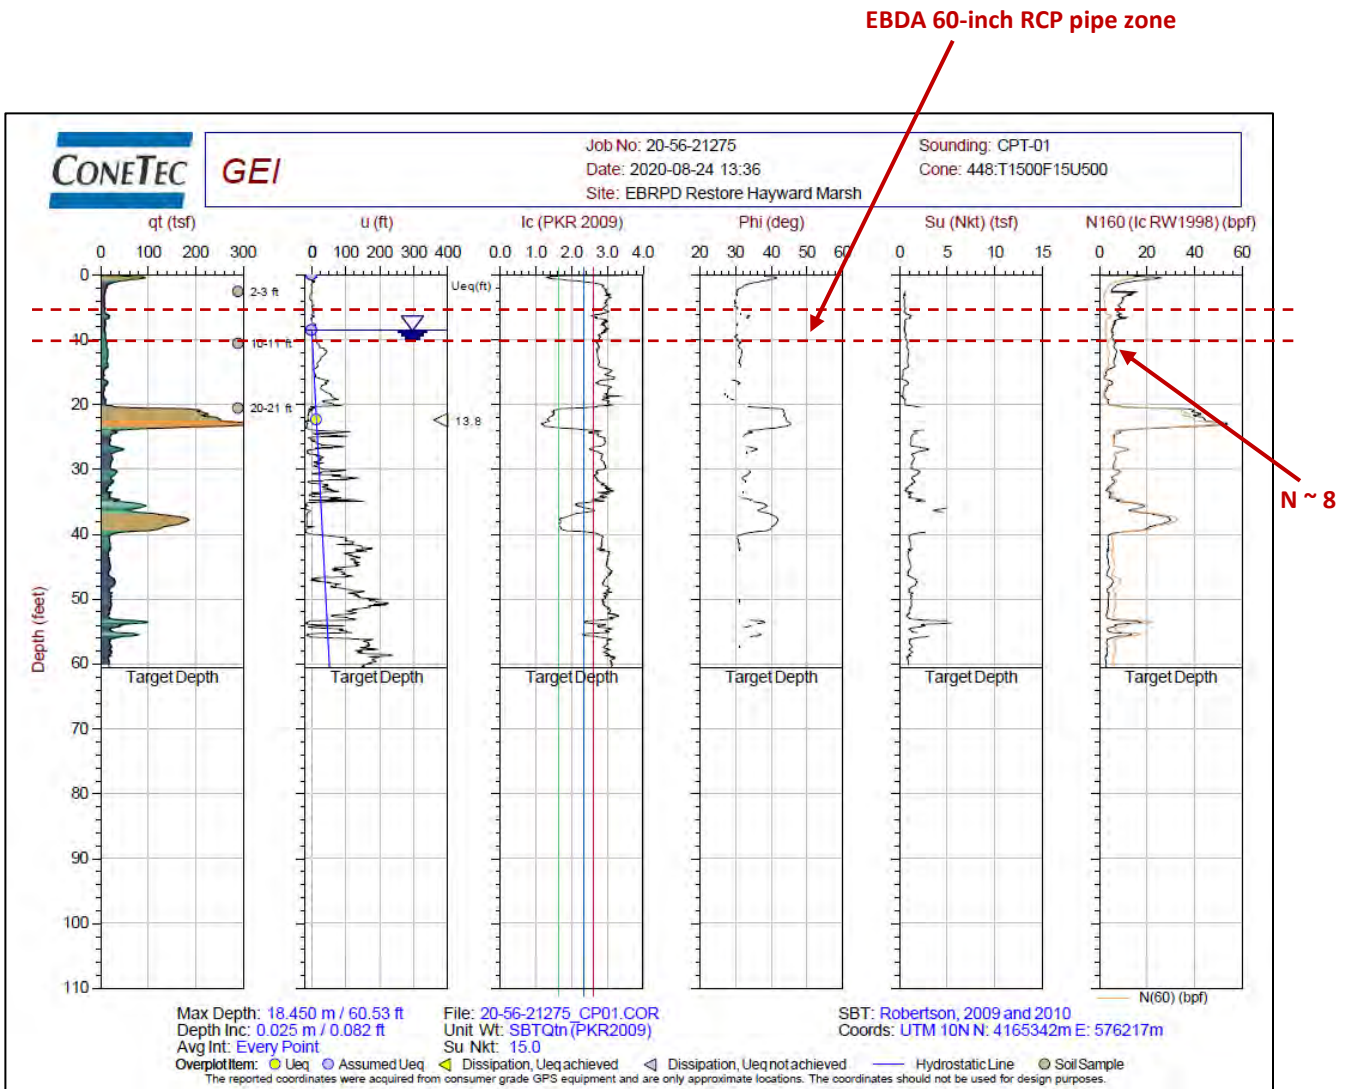
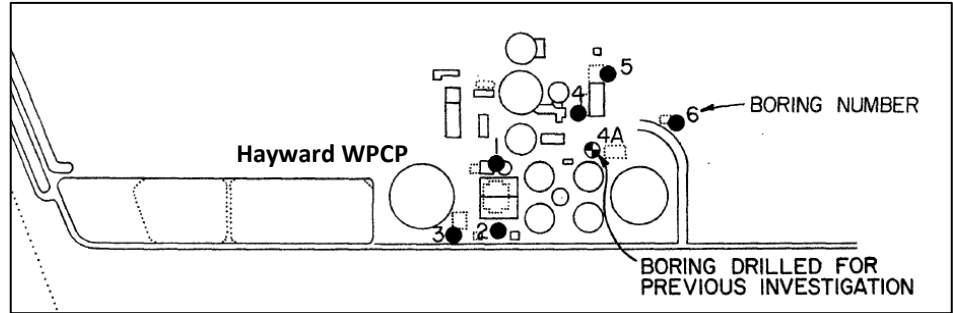
Figure 6 – Advanced Plot of CPT-01 with Standard Penetration Test (SPT) blow count correlation N1(60).

N1(60) is approx. N = 8 at the invert depth of the EBDA 60-inch RCP force main = medium stiff clays

No Bay Mud in CPT-01, see also Figure 4 for Young Bay Mud thickness contours.

EBDA 60-inch RCP pipe zone,
 top of pipe ~ El. 0

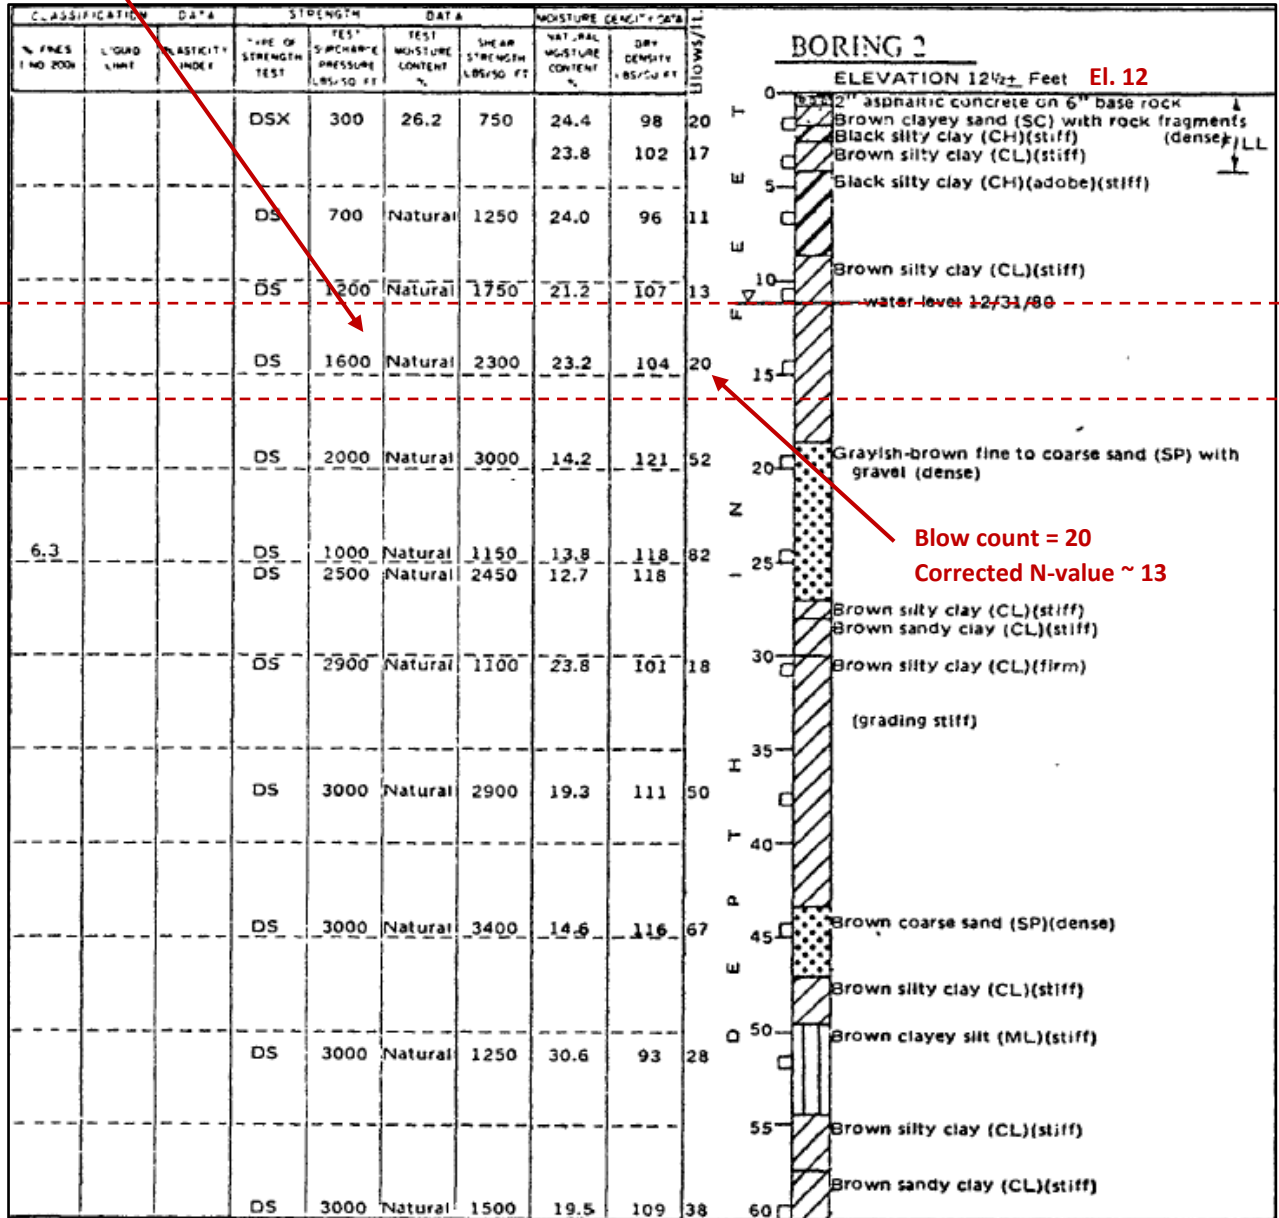
Also in the vicinity of the crossing location is the City of Hayward's Water Pollution Control Plant (WPCP). Figure 7 is an excerpt from the most recent geotechnical investigation completed at the WPCP by Engeo showing test boring B-2, about 800 feet north of the crossing. As seen in test boring B-2 the soils at the invert depth of the EBDA 60-inch RCP force main pipeline are stiff clays with a Standard Penetration Test blow count of $N = 13$.

Figure 7 – Test Boring B-2 at southern border of Hayward WPCP in 1981, shortly after EBDA construction approx. 800 feet north of crossing. (B-3 only drilled to 15 feet bgs)
 Note soils at and below the invert depth of the EBDA 60-inch RCP force main = **Brown, Stiff, Silty Clays (N ~13)**.

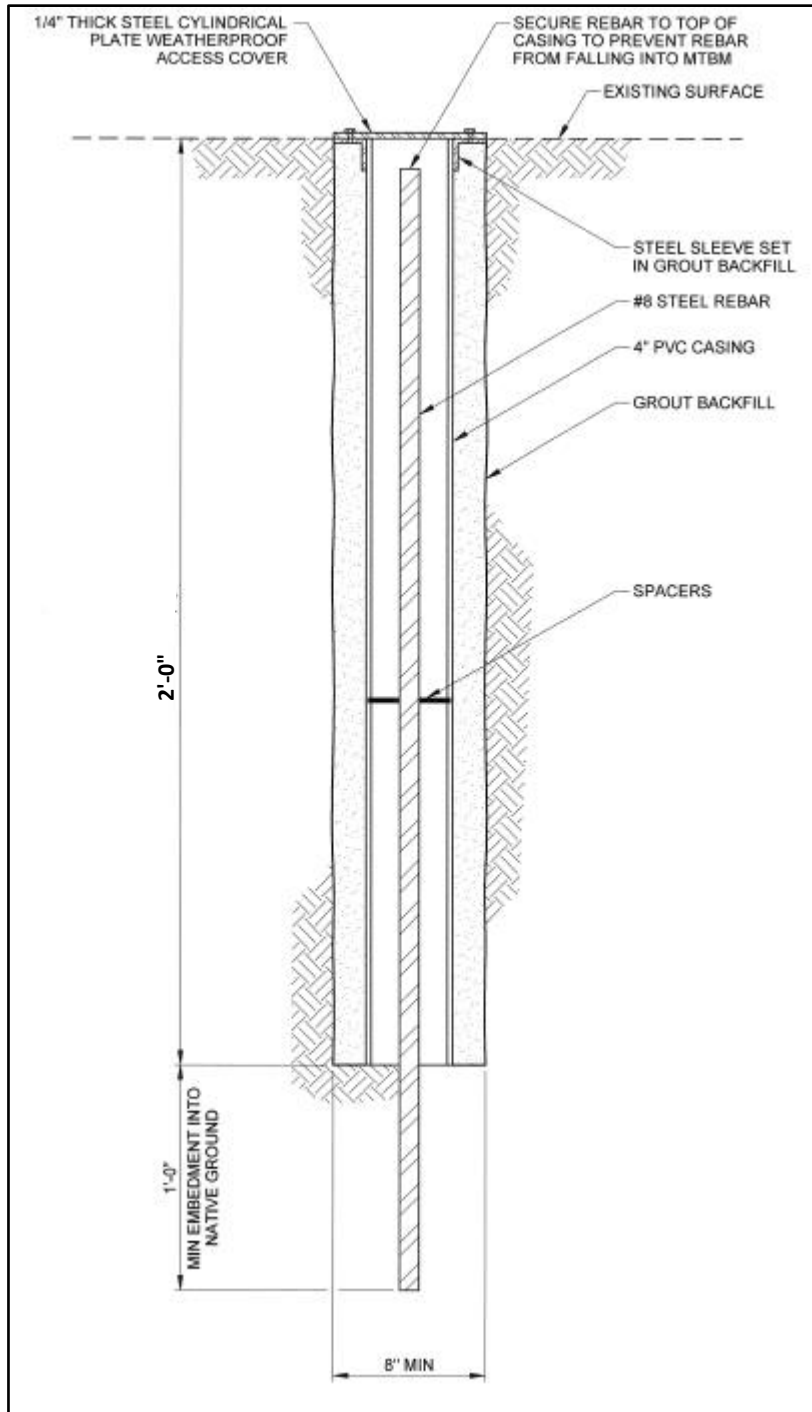
Figure 8 – Example detail for Surface Settlement Monitoring Point (SSMP)

4. Install a Surface Settlement Monitoring Point in the drainage channel berm directly over the EBDA 60-inch RCP force main pipeline to monitor the surface of the berm for any change in elevation (i.e., berm settlement from long-term repetitive construction traffic). See Figure 8 for an example of a surface settlement monitoring point (SSMP).

Survey monthly during active construction traffic on the access route. Recommended action levels:

- Report any berm settlement of more than 1 inch;
 - Stop work at any berm settlement of more than 2 inches. At this point carefully inspect the berm and check elevations of the top of the EBDA 60-inch RCP force main pipeline.
5. Install Utility Monitoring Points on each side of the drainage channel south berm and construction access route near the top of the berm but outside the construction access route traffic path. See Figure 9 for an example of a utility monitoring point.

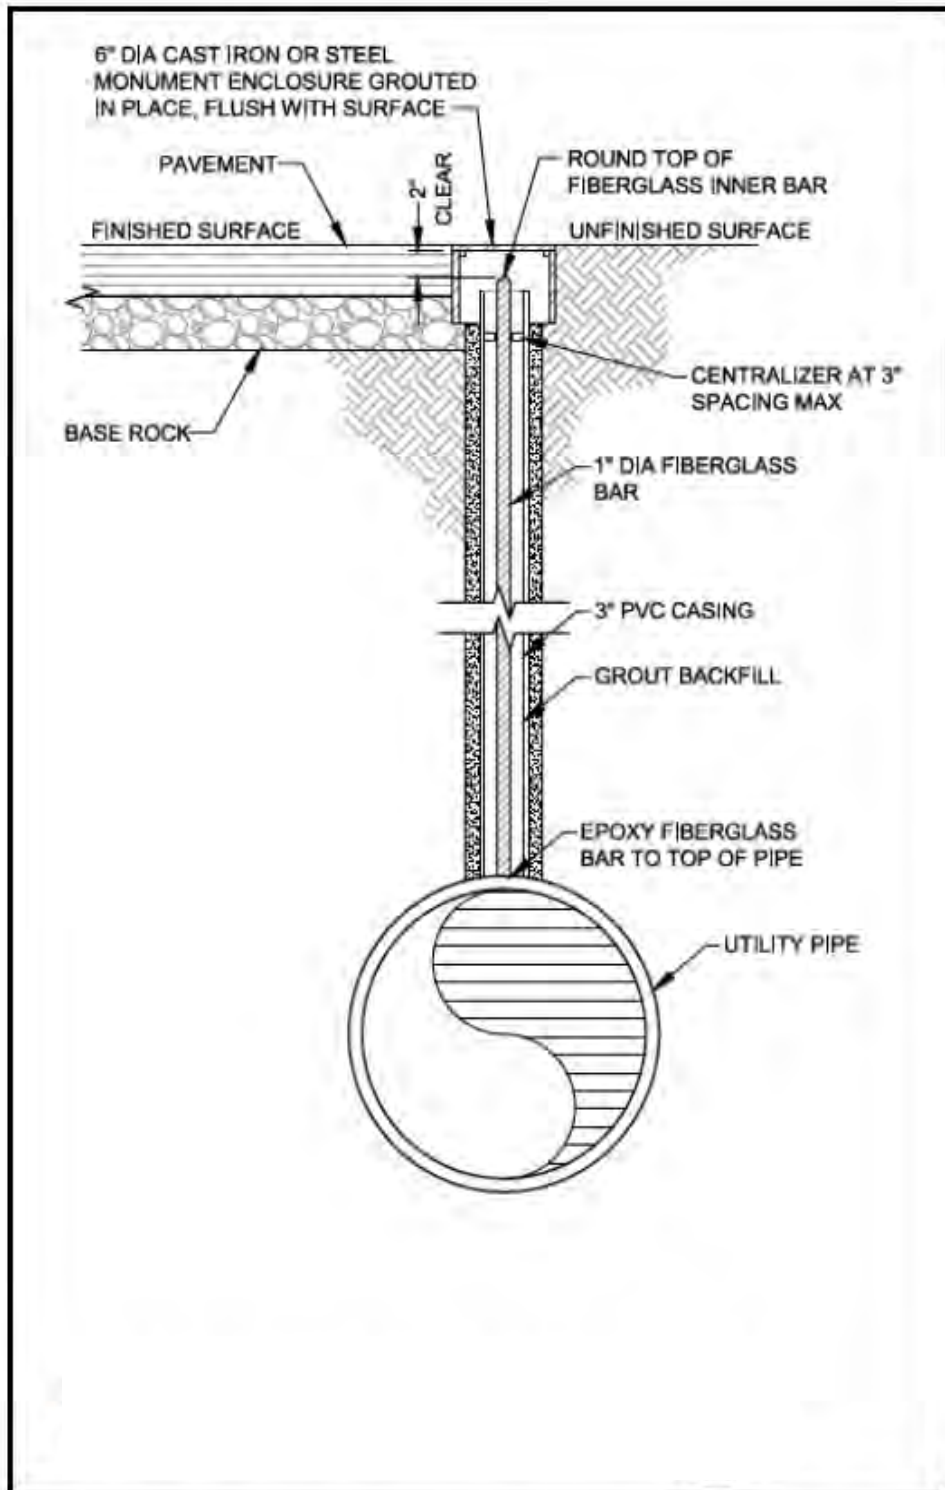
Figure 9 – Example detail for Utility Monitoring Point (UMP)

Survey monthly during active construction traffic on the access route. Recommended action levels:

- Report any 60-inch RCP force main pipeline settlement of more than 0.5 inches;
 - Stop work at any 60-inch RCP force main pipeline settlement of more than 1 inch. At this point evaluate mitigation measures to eliminate construction traffic loading on the EBDA 60-inch force main pipeline (e.g., at-grade bridge).
6. Do not allow localized stockpiling of soils or construction materials or construction equipment on the EBDA easement.
